Memo

To: Dayna Claybourn, A/Compliance Delivery Manager, Wide Bay Burnett
From: Paul Prenzler, Principal Coastal Engineer, Coastal and Marine Assessment
Date: 4 February 2016
Re: Assessment of the Seawall at Toogoom, Hervey Bay

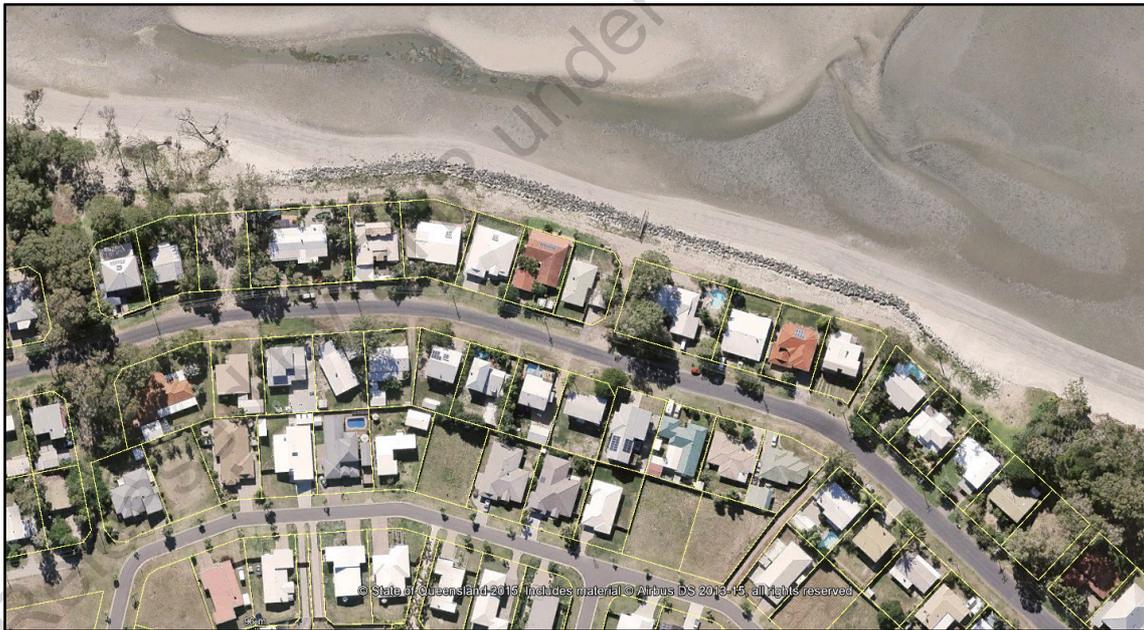
There has been a long-term coastal erosion problem along this section of coast and in the vicinity of the seawall the beach has receded over 30 metres in the last 25 years. Due to this long-term recession the properties from 48 (western end) to 80 (eastern end) Kingfisher Parade, Toogoom were at considerable risk of erosion associated with future storm events and this led to the construction of the subject seawall (Figure 2).

Figure 2: Aerial photograph (May 2015) showing extent of Kingfisher Parade seawall

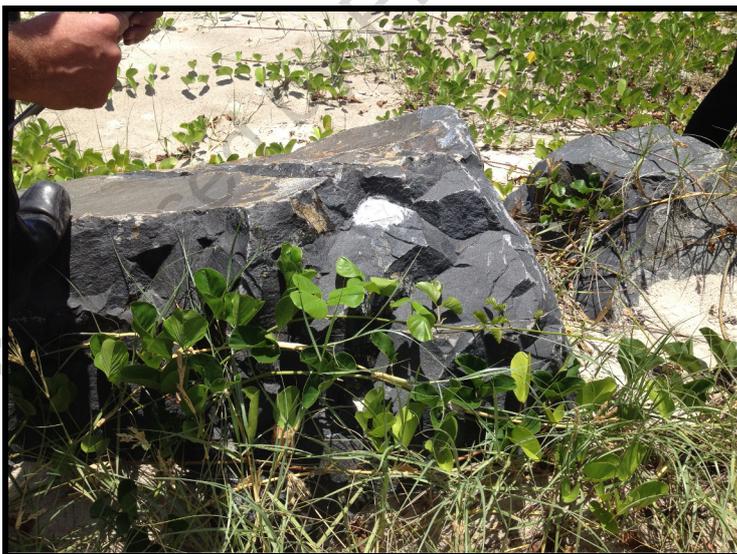
FCRC supplied copies of the as-constructed survey (dated 17/5/14) and follow-up survey (dated 20/11/15) of the seawall using 60 markers (see Figure 3) attached to individual armour units (Attachment 2).

The follow-up survey located 50 markers (other markers were below sand level and excavation was not undertaken to locate these other markers) and a comparison of the data indicates minimal settlement and movement of the seawall since the as-constructed survey in May 2014. It should be noted that rock seawalls are structures that will move and settle over time as they are exposed to storm events.

Figure 3: Example of an armour unit ID plate on the Toogoom Seawall
