Report on: Erosion at Cloherty's Peninsular, Moreton Island

1.0 Introduction

This report has been prepared by the Coastal Management Unit of Environment Planning for Moreton Bay Marine Park Operations to assess the coastal processes affecting the eastern shoreline of Cloherty's Peninsular, Moreton Island. Erosion of this beach has exposed a disused landfill site on a reserve (Lot 51 on SL8794) located east of the Koorungal Township.

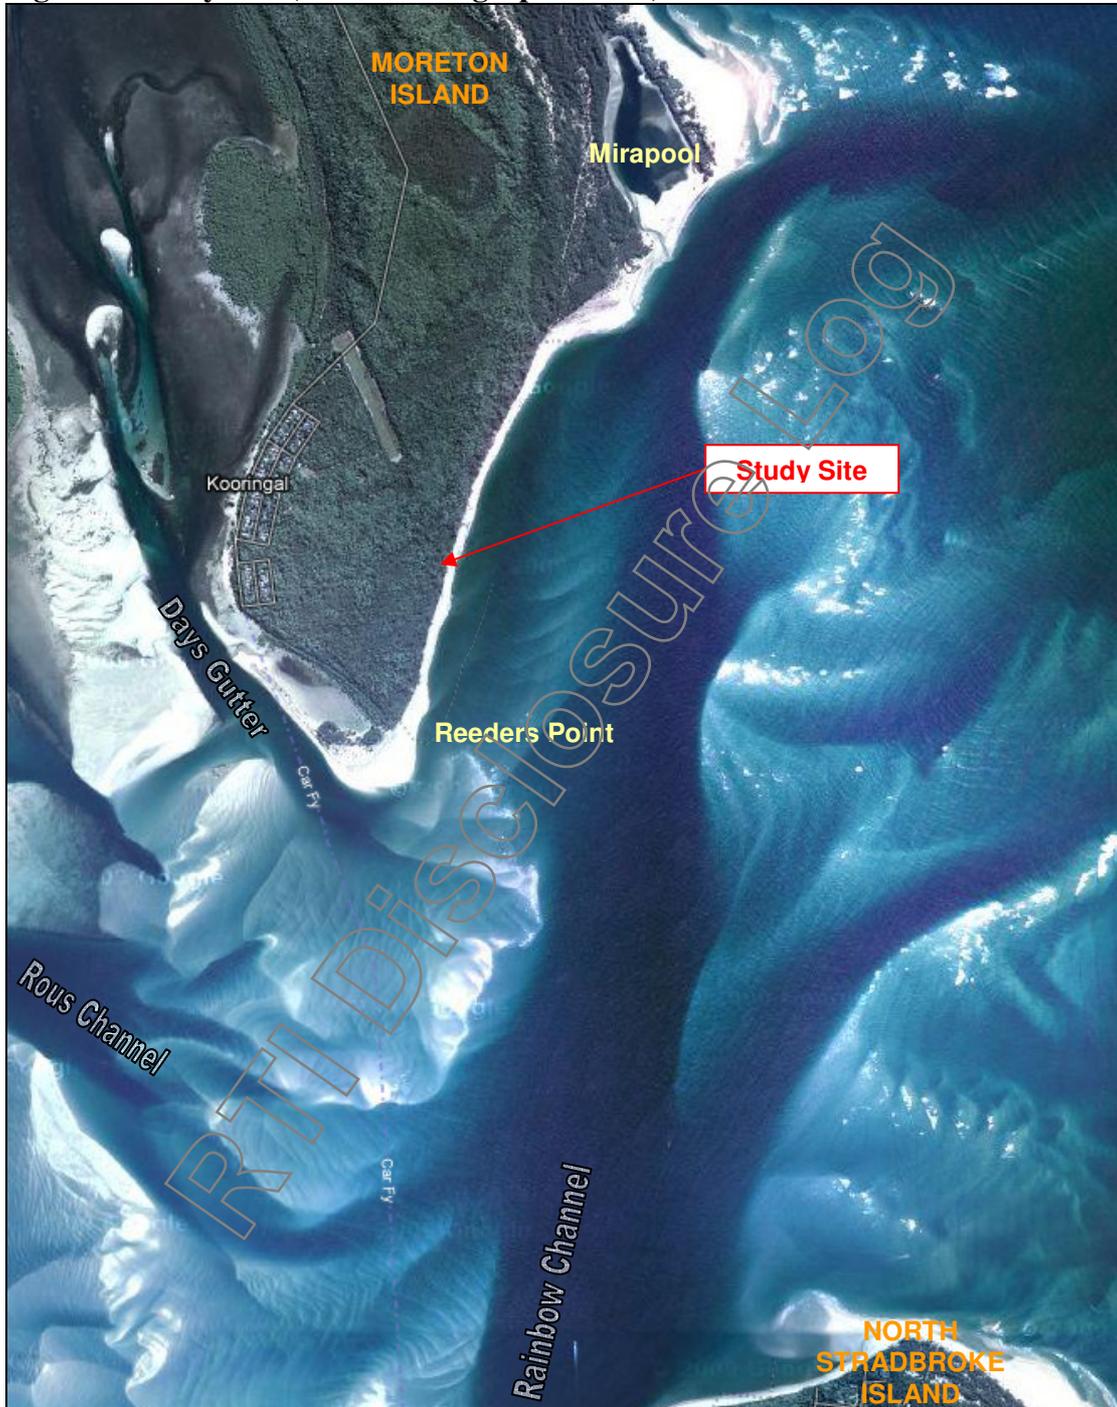
Figure 1: Study Site (Aerial Photograph – 2009)

The study site is the eastern beach of Cloherty's Peninsular, Moreton Island between Mirapool to the north and Reeders Point to the south (refer Figure 1). This beach has a south-easterly aspect and is exposed to waves from the east to north-east sector. The site is protected from the prevailing south-easterly waves by North Stradbroke Island. The site is influenced by the tidal channels within South Passage, the entrance to Moreton Bay between North Stradbroke and Moreton Islands.

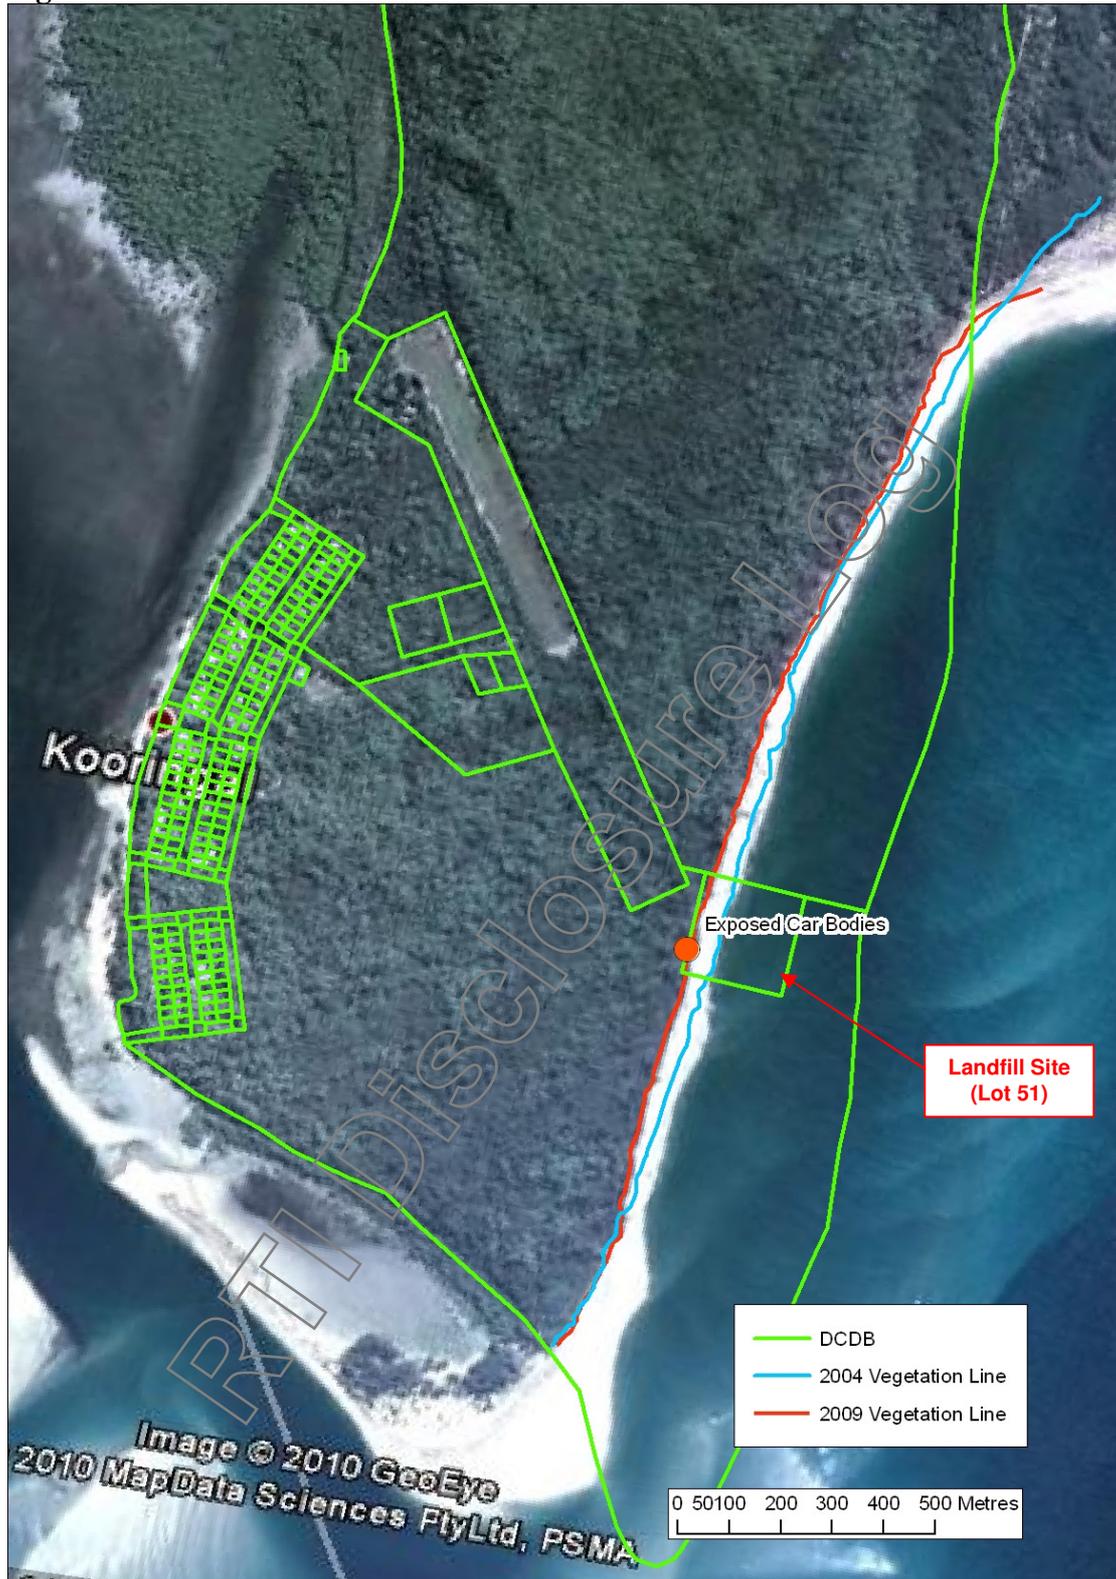
Figure 2: Shoreline Erosion between 2004 and 2009

The study site was inspected on 13 July 2010 with QPWS officers to ascertain the extent of erosion that has occurred in the last 12 months. Figure 2 shows the location of the landfill site and exposed waste in relation to the 2004 and 2009 seaward

vegetation line (assumed shoreline). Figure 3 shows the seaward vegetation extent and edge of exposed landfill measured on 13 July 2010 in relation to the 2004 and 2009 shoreline. Since 2004 the shoreline has eroded at a consistent rate of approximately 10m/year.

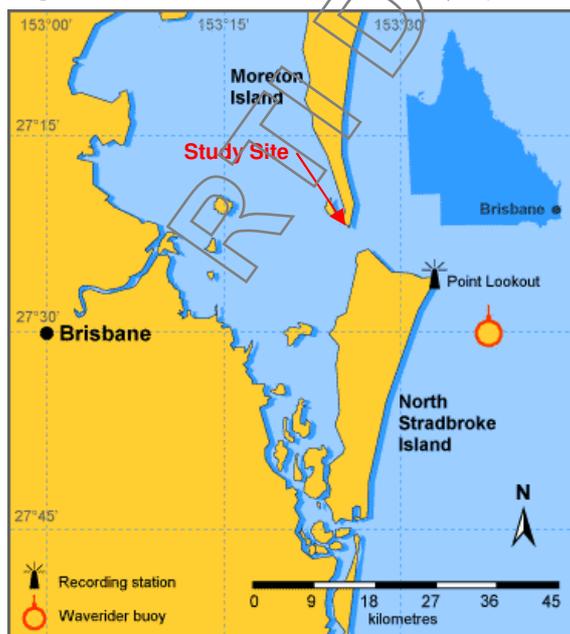
Figure 4: Brisbane Waverider Buoy Location

DERM records deepwater wave conditions from a buoy located south-east of Point Lookout on North Stradbroke Island (refer Figure 4). Wave heights and periods have been recorded at this site since 1976 and wave direction since 1998. Figure 5 shows the deepwater wave climate for this section of coast is dominated by waves from the southeast quadrant with a significant wave height (H_s) typically between 1.5 to 2.5m.

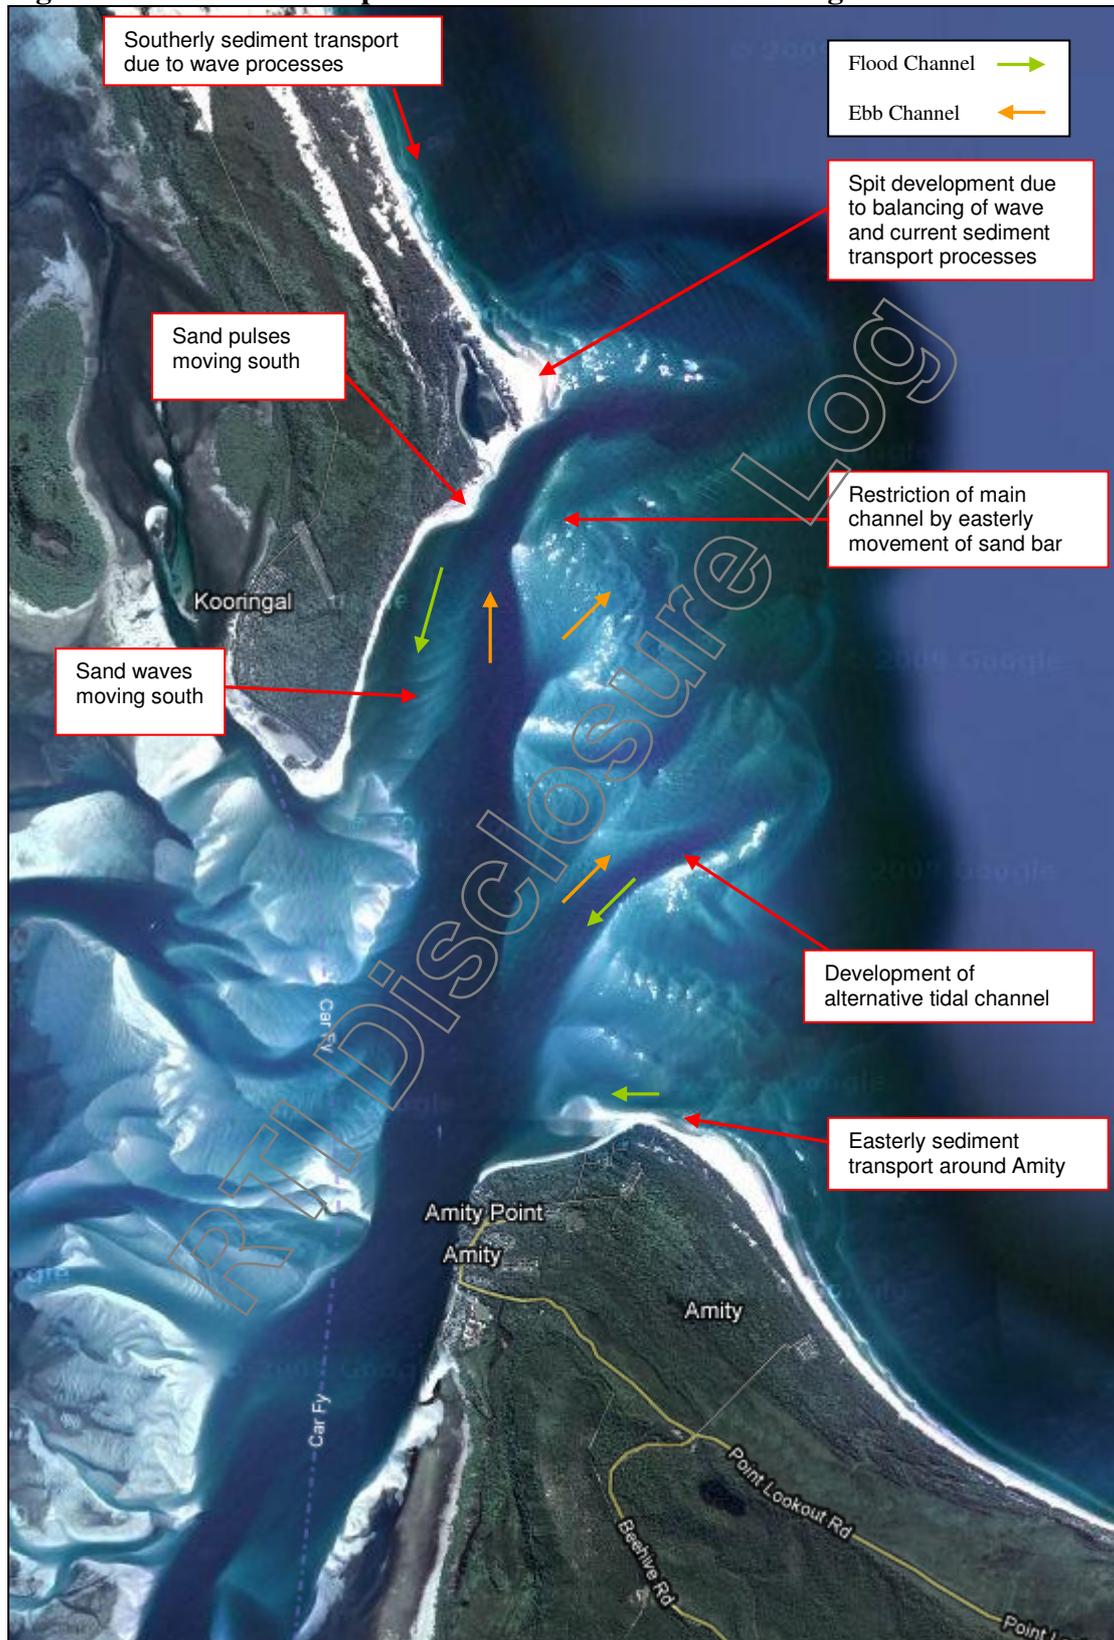
Figure 6: Sediment Transport Processes within South Passage

South Passage is a high dynamic system and sediment transport processes are very complex. Figure 6 shows some of the main features associated with the sediment transport processes through South Passage determined from the most recent aerial photography.

The 2009 aerial photograph shows that South Passage consists of a complex network of channels and sand banks dominated by the north-south orientated Rainbow Channel. The magnitude of the flood tide current through this channel is greater than the ebb tide current due to the local tide characteristics. This drives a southern transport of sand along the southeast foreshore of Moreton Island south of Mirapool. Sand pulses immediately south of Mirapool and the orientation of sand waves within the channel adjacent to the foreshore indicate this southerly sand transport.

The Rainbow Channel is being restricted at the northern end by the development of the Mirapool spit and the western migration of offshore sand bars. In the long-term the restriction of the main channel may lead to the development and increased dominance of another channel. The 2009 aerial photograph shows an alternative tidal channel is forming further to the south and under favourable conditions may become the more dominant channel over time with the progressive abandonment of this channel.

As previously discussed there is a southeast dominated wave climate in this region. However, along the southeast foreshore of Moreton Island waves are transformed by Point Lookout and the South Passage bar resulting in an east to northeast dominated wave climate driving a southern longshore transport of sand. Further north along Moreton Island the effect of Point Lookout and the South Passage bar on the wave climate reduces and wave are predominately from the southeast and the longshore transport is to the north. There is a transition point along the eastern foreshore on Moreton Island where the beach is often eroded back to coffee rock deposits.

In the long-term a switch in dominance of tidal channels through South Passage would reduce the erosion pressure on the study site. Under such a scenario the sand banks southeast of Mirapool would continue to migrate westward and eventually lead to the accretion of the beach at the study site. Such processes operate over a very long
