**Infrastructure Removal Characterisation and Environmental Site Assessment
Former Quilpie Depot CCM104Q
Graphical Trend Analysis - MW7**

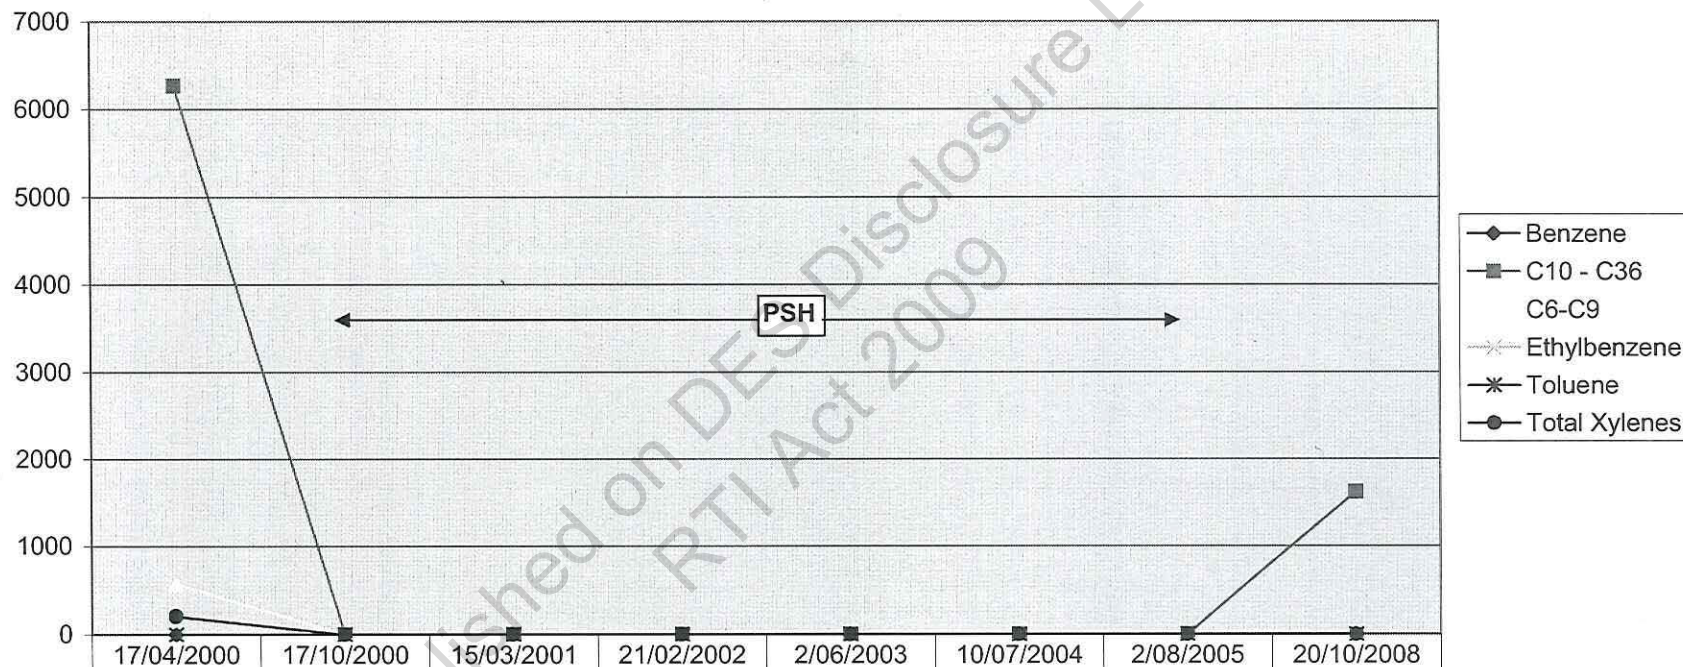
17/04/2000	17/10/2000	15/03/2001	21/02/2002	2/06/2003	10/07/2004	2/08/2005	20/10/2008
◆ Benzene	0	0	0	0	0	0	0	0
■ C10 - C36	6272	0	0	0	0	0	0	1620
□ C6-C9	571	0	0	0	0	0	0	0
✦ Ethylbenzene	0	0	0	0	0	0	0	3
✱ Toluene	0	0	0	0	0	0	0	0
● Total Xylenes	207	0	0	0	0	0	0	0

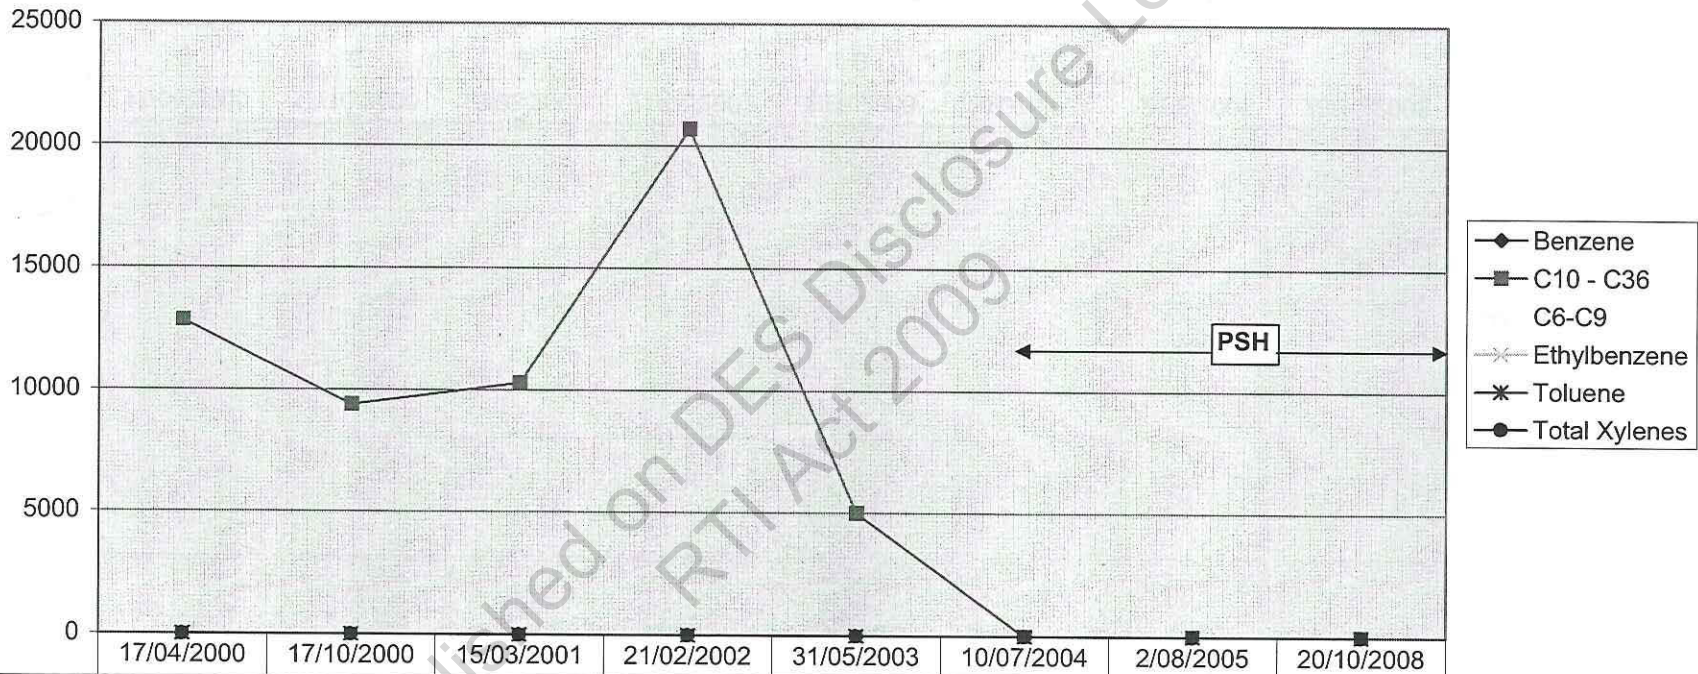
**Infrastructure Removal Characterisation and Environmental Site Assessment
Former Quilpie Depot CCM104Q
Graphical Trend Analysis - MW8**

17/04/2000	17/10/2000	15/03/2001	21/02/2002	31/05/2003	10/07/2004	2/08/2005	20/10/2008
◆ Benzene	0	0	0	3	0	0	0	0
■ C10 - C36	12852	9400	10300	20700	5000	0	0	0
□ C6-C9	0	0	0	0	17	0	0	0
✕ Ethylbenzene	0	0	0	0	0	0	0	0
* Toluene	0	0	0	0	0	0	0	0
● Total Xylenes	0	0	0	0	0	0	0	0

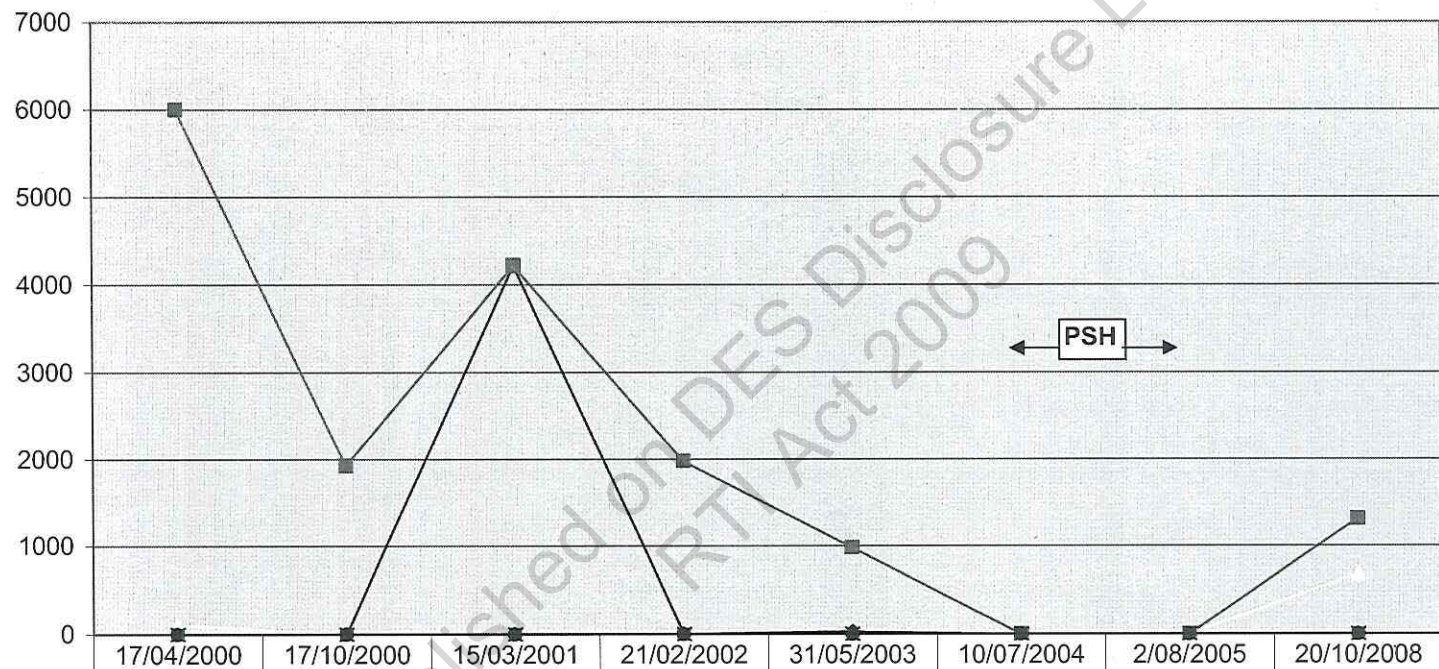
**Infrastructure Removal Characterisation and Environmental Site Assessment
Former Quilpie Depot CCM104Q
Graphical Trend Analysis - MW9**

17/04/2000	17/10/2000	15/03/2001	21/02/2002	31/05/2003	10/07/2004	2/08/2005	20/10/2008
◆ Benzene	0	0	4220	0	28	0	0	0
■ C10 - C36	6008	1930	4220	1980	980	0	0	1310
■ C6-C9	109	0	0	0	0	0	0	680
✦ Ethylbenzene	0	0	0	0	0	0	0	0
* Toluene	0	0	0	0	0	0	0	0
● Total Xylenes	0	0	0	0	0	0	0	0

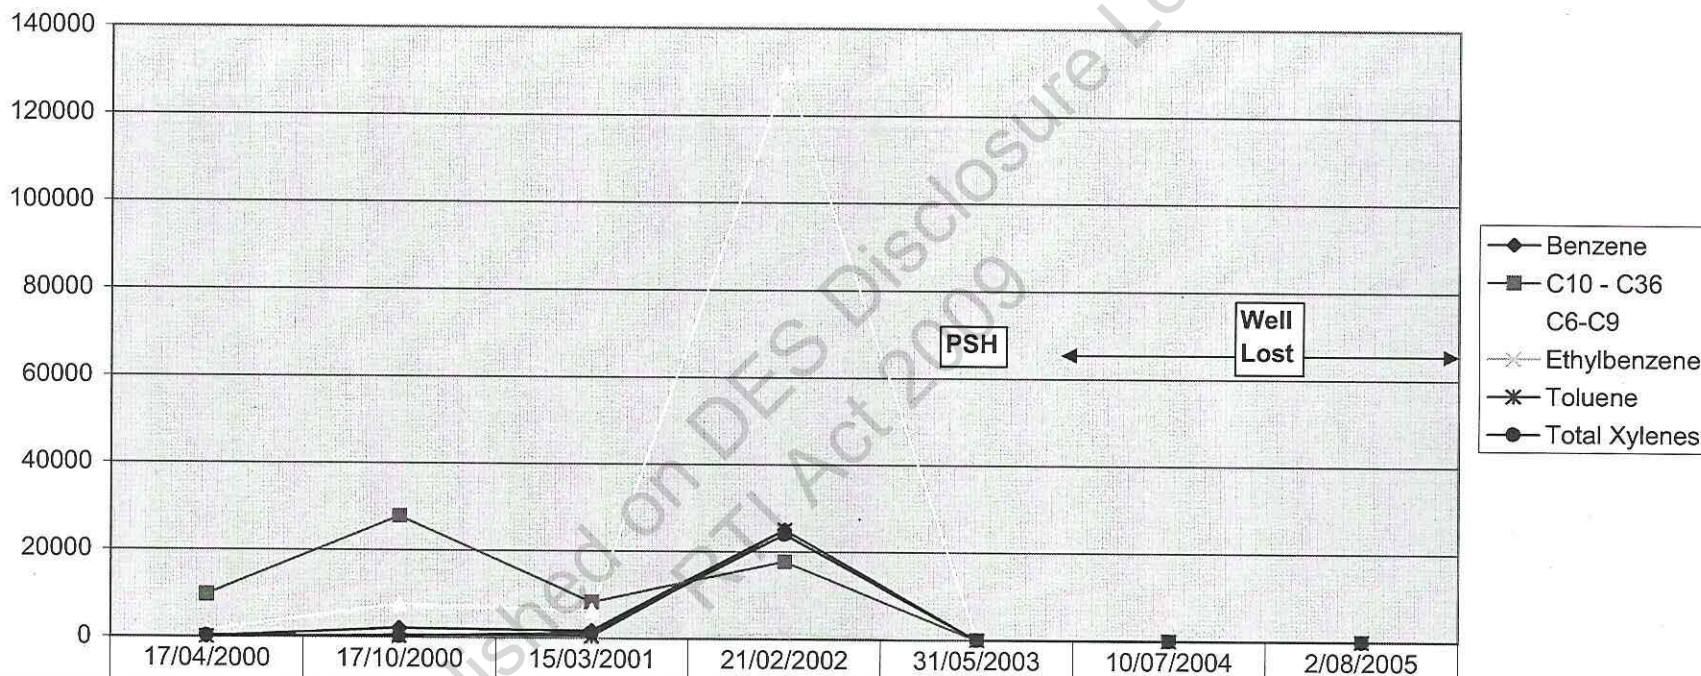
**Infrastructure Removal Characterisation and Environmental Site Assessment
Former Quilpie Depot CCM104Q
Graphical Trend Analysis - MW10**

◆ Benzene	39	2200	1800	25000	0	0	0
■ C10 - C36	9722	27800	8300	17700	0	0	0
□ C6-C9	1580	7700	6400	130000	0	0	0
× Ethylbenzene	0	0	0	1200	0	0	0
* Toluene	77	510	560	25000	0	0	0
● Total Xylenes	332	320	1300	24000	0	0	0

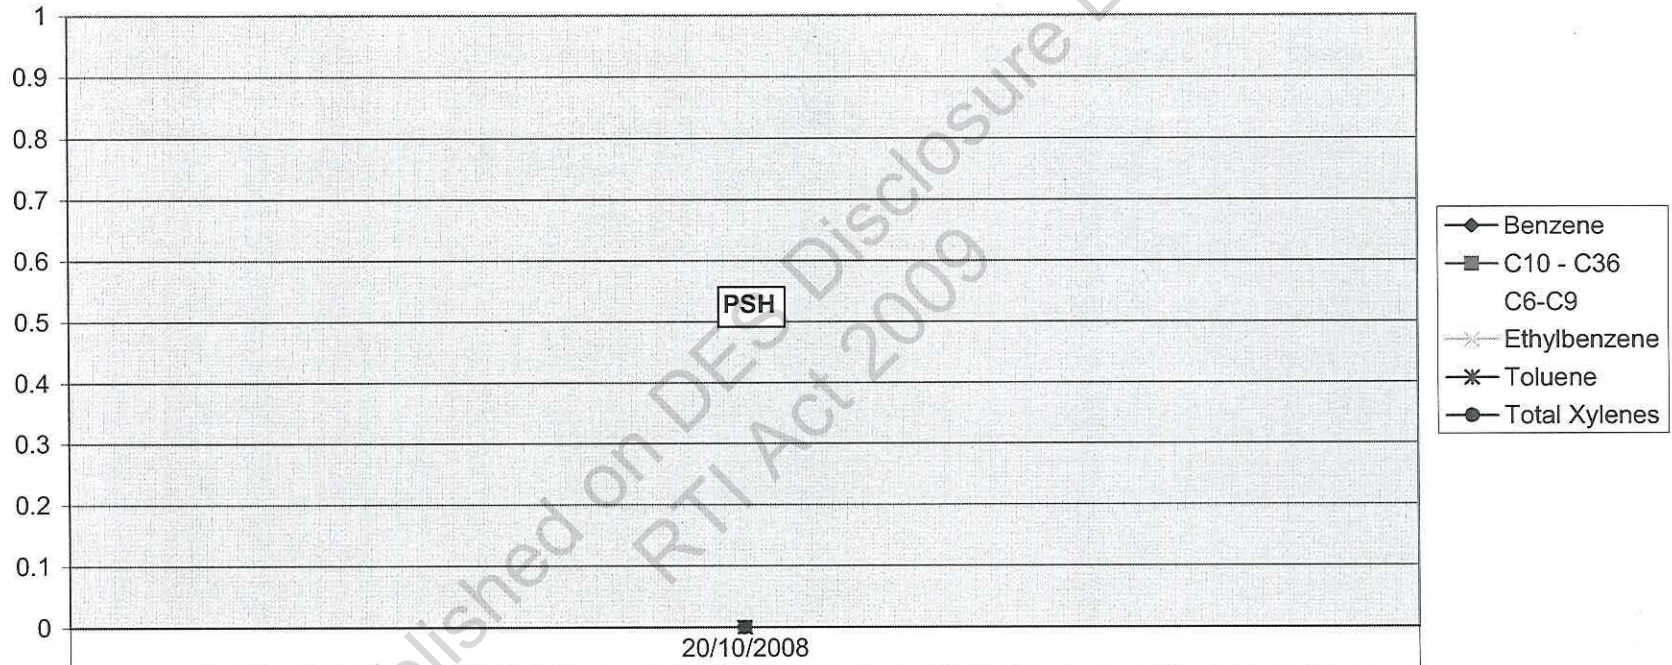
**Infrastructure Removal Characterisation and Environmental Site Assessment
Former Quilpie Depot CCM104Q
Graphical Trend Analysis - MW10A**

◆ Benzene	0
■ C10 - C36	0
□ C6-C9	0
✕ Ethylbenzene	0
* Toluene	0
● Total Xylenes	0

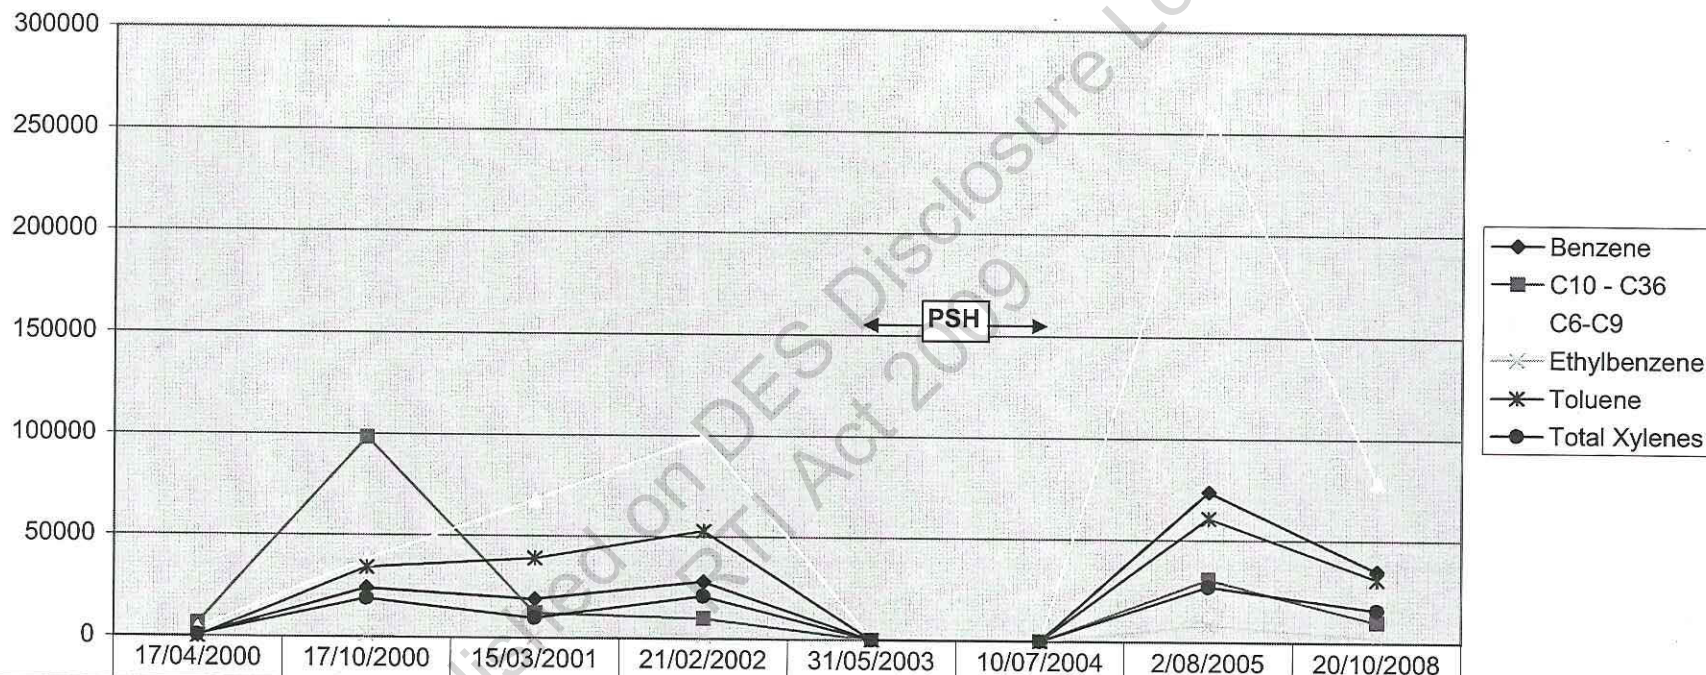
**Infrastructure Removal Characterisation and Environmental Site Assessment
Former Quilpie Depot CCM104Q
Graphical Trend Analysis - MW11**

17/04/2000	17/10/2000	15/03/2001	21/02/2002	31/05/2003	10/07/2004	2/08/2005	20/10/2008
◆ Benzene	533	24000	19000	28000	0	0	74000	35000
■ C10 - C36	6611	98600	12300	10100	0	0	30700	10150
● C6-C9	3740	38000	68000	100000	0	0	260000	79000
* Ethylbenzene	0	1400	820	1800	0	0	8100	2600
✱ Toluene	0	34000	39000	53000	0	0	61000	31000
● Total Xylenes	962	19000	9900	21000	0	0	27200	16000

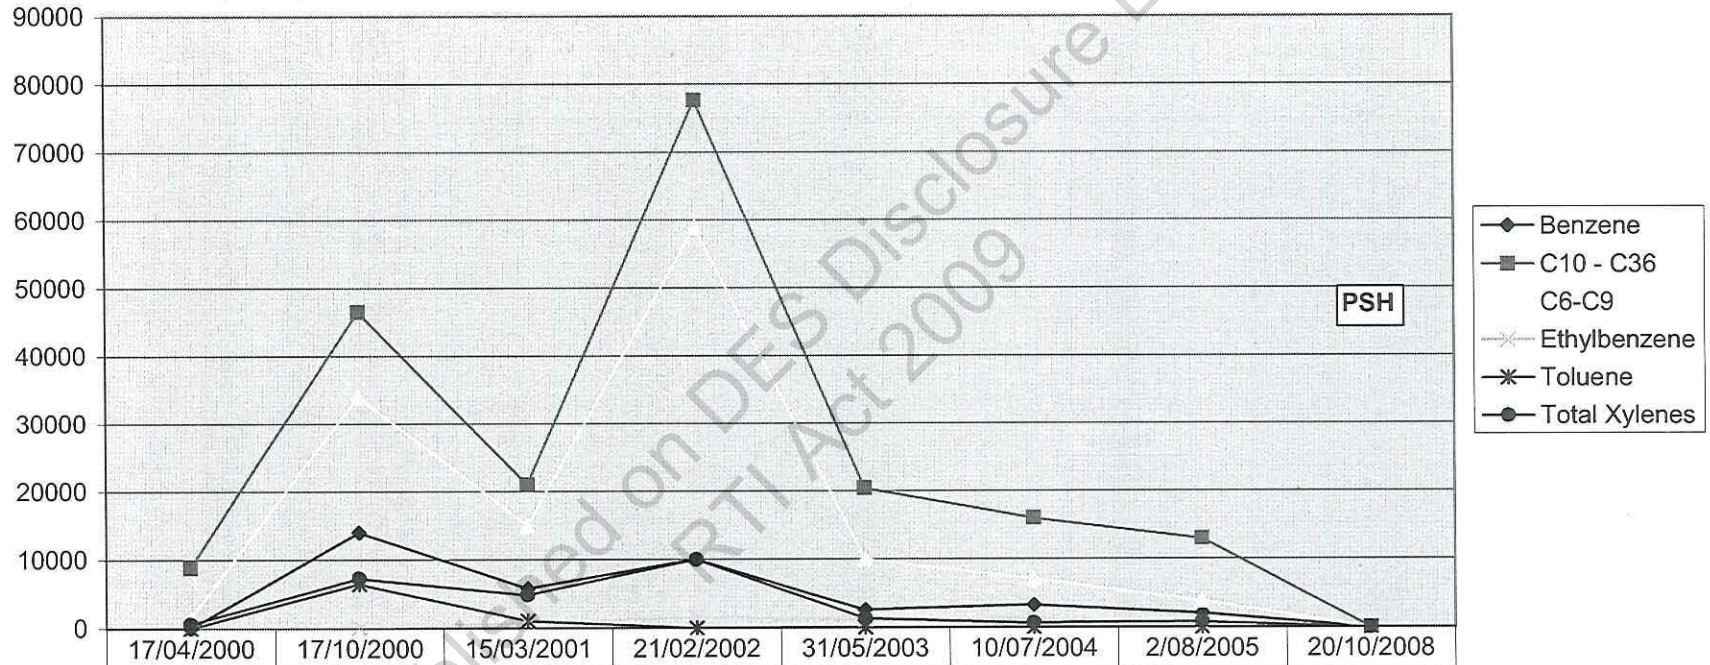
**Infrastructure Removal Characterisation and Environmental Site Assessment
Former Quilpie Depot CCM104Q
Graphical Trend Analysis - MW12**

17/04/2000	17/10/2000	15/03/2001	21/02/2002	31/05/2003	10/07/2004	2/08/2005	20/10/2008
◆ Benzene	0	14000	5800	10000	2600	3300	2100	0
■ C10 - C36	8810	46600	21000	77700	20400	16000	13000	0
● C6-C9	1520	34000	15000	59000	10000	7100	3900	0
⊠ Ethylbenzene	0	120	730	1600	1200	1300	610	0
* Toluene	0	6500	1100	0	54	0	0	0
● Total Xylenes	653	7300	4900	10000	1340	670	810	0

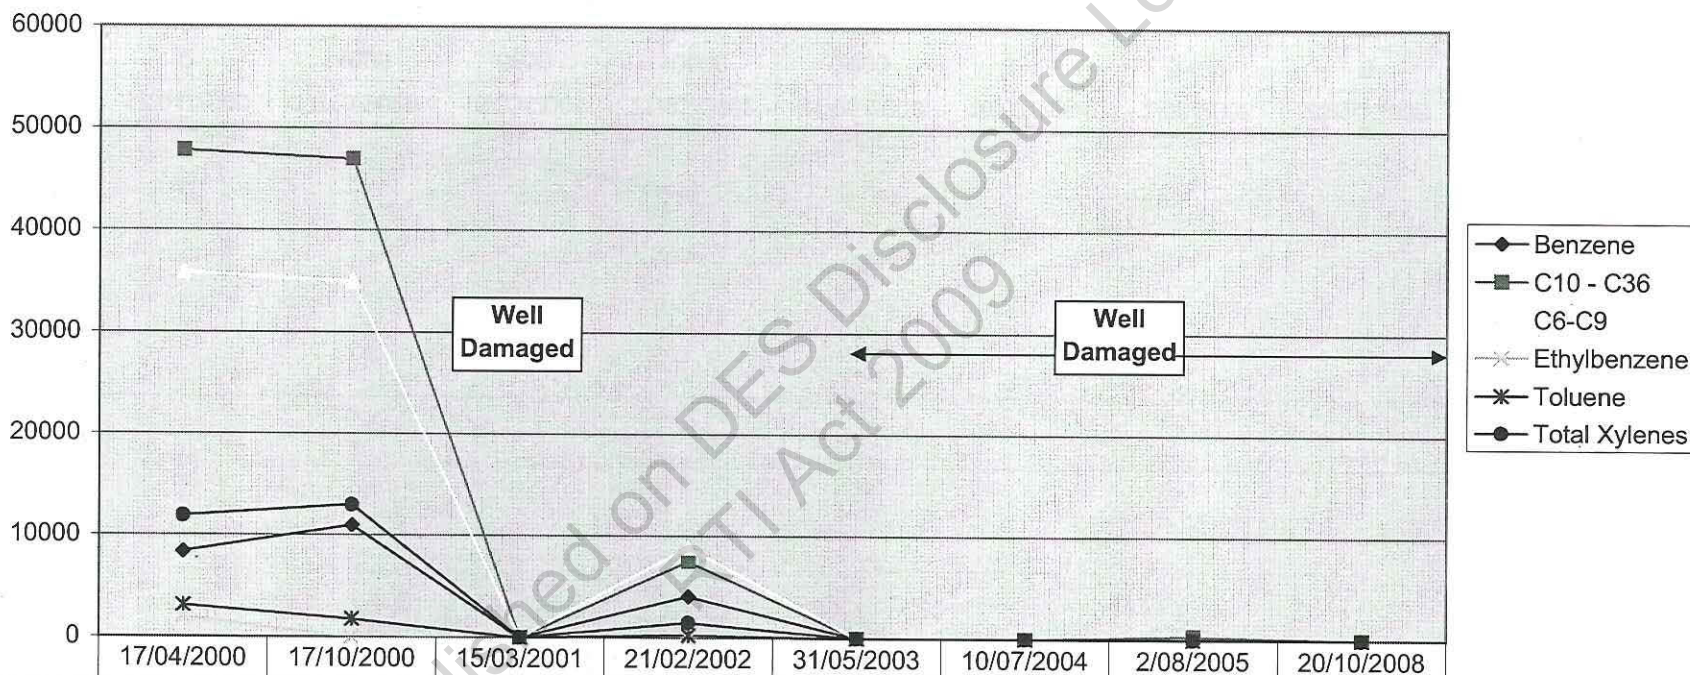
**Infrastructure Removal Characterisation and Environmental Site Assessment
Former Quilpie Depot CCM104Q
Graphical Trend Analysis - MW13**

17/04/2000	17/10/2000	15/03/2001	21/02/2002	31/05/2003	10/07/2004	2/08/2005	20/10/2008
◆ Benzene	8390	11000	0	4100	0	0	0	0
■ C10 - C36	47875	47000	0	7500	0	0	350	0
□ C6-C9	35900	35000	0	8900	0	0	0	0
✕ Ethylbenzene	2040	0	0	0	0	0	0	0
* Toluene	3110	1800	0	310	0	0	0	0
● Total Xylenes	11890	13000	0	1500	0	0	0	0

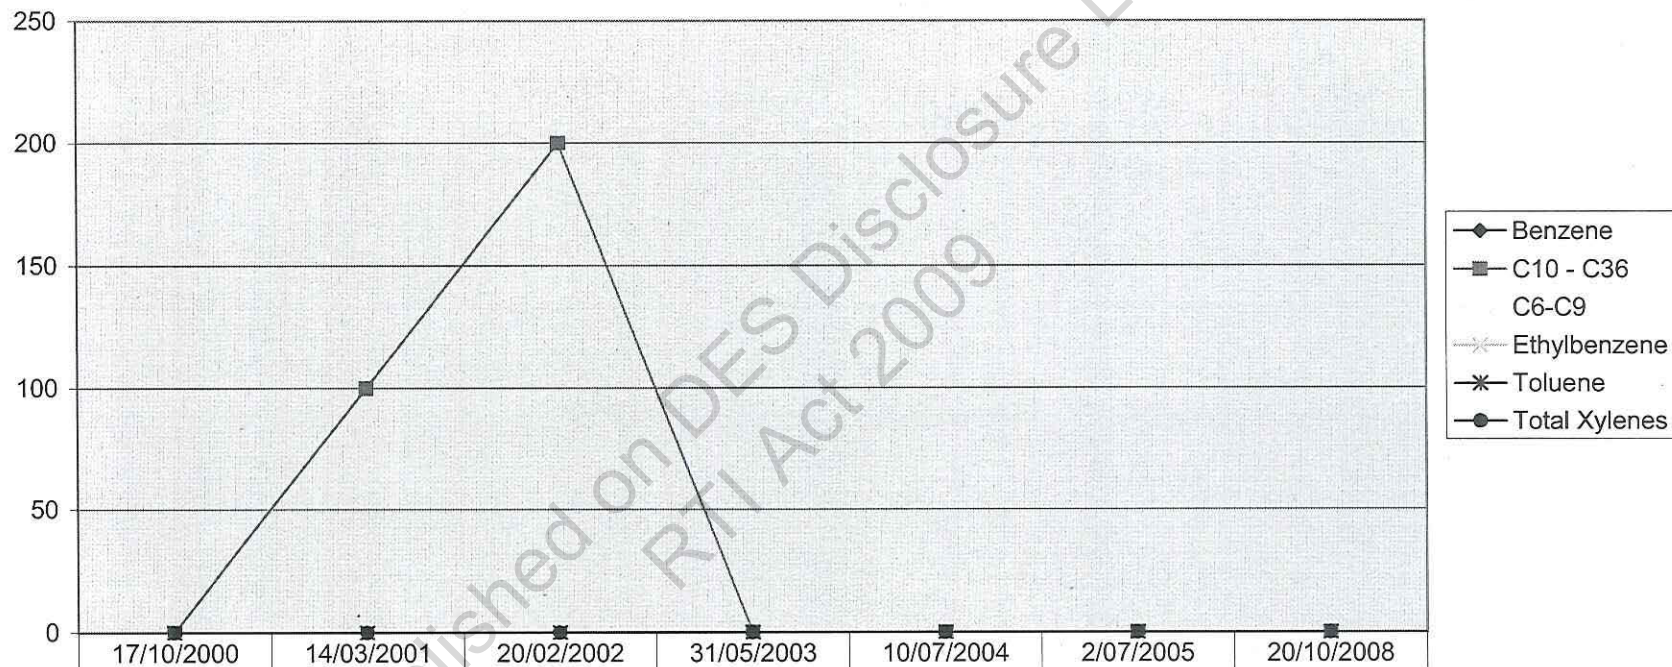
**Infrastructure Removal Characterisation and Environmental Site Assessment
Former Quilpie Depot CCM104Q
Graphical Trend Analysis - MW14**

17/10/2000	14/03/2001	20/02/2002	31/05/2003	10/07/2004	2/07/2005	20/10/2008
◆ Benzene	0	0	0	0	0	0	0
■ C10 - C36	0	100	200	0	0	0	0
○ C6-C9	0	0	0	0	0	0	0
✦ Ethylbenzene	0	0	0	0	0	0	0
✱ Toluene	0	0	0	0	0	0	0
● Total Xylenes	0	0	0	0	0	0	0

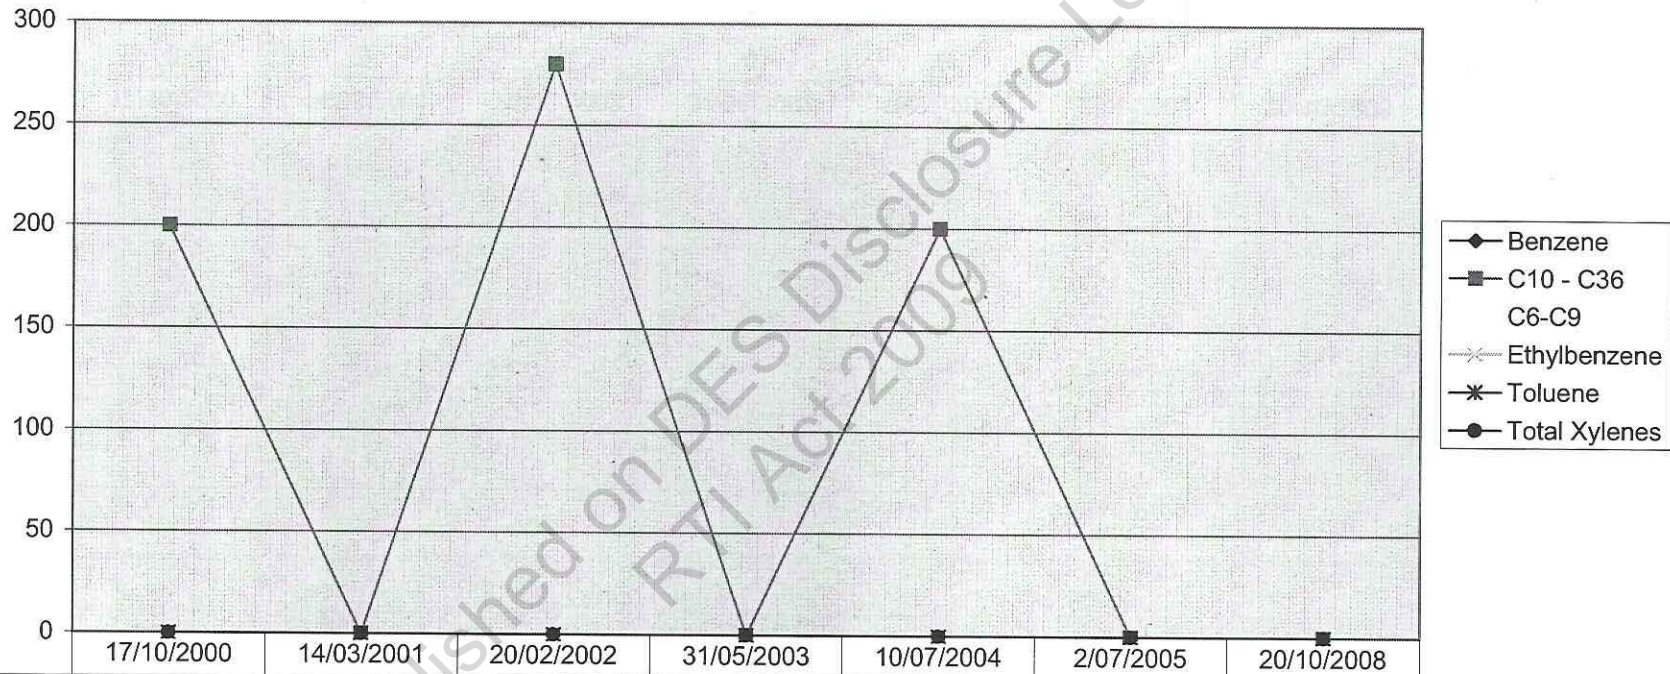
**Infrastructure Removal Characterisation and Environmental Site Assessment
Former Quilpie Depot CCM104Q
Graphical Trend Analysis - MW15**

17/10/2000	14/03/2001	20/02/2002	31/05/2003	10/07/2004	2/07/2005	20/10/2008
◆ Benzene	0	0	0	0	0	0	0
■ C10 - C36	200	0	280	0	200	0	0
● C6-C9	0	0	0	0	0	0	0
⊠ Ethylbenzene	0	0	0	0	0	0	0
* Toluene	0	0	0	0	0	0	0
● Total Xylenes	0	0	0	0	0	0	0

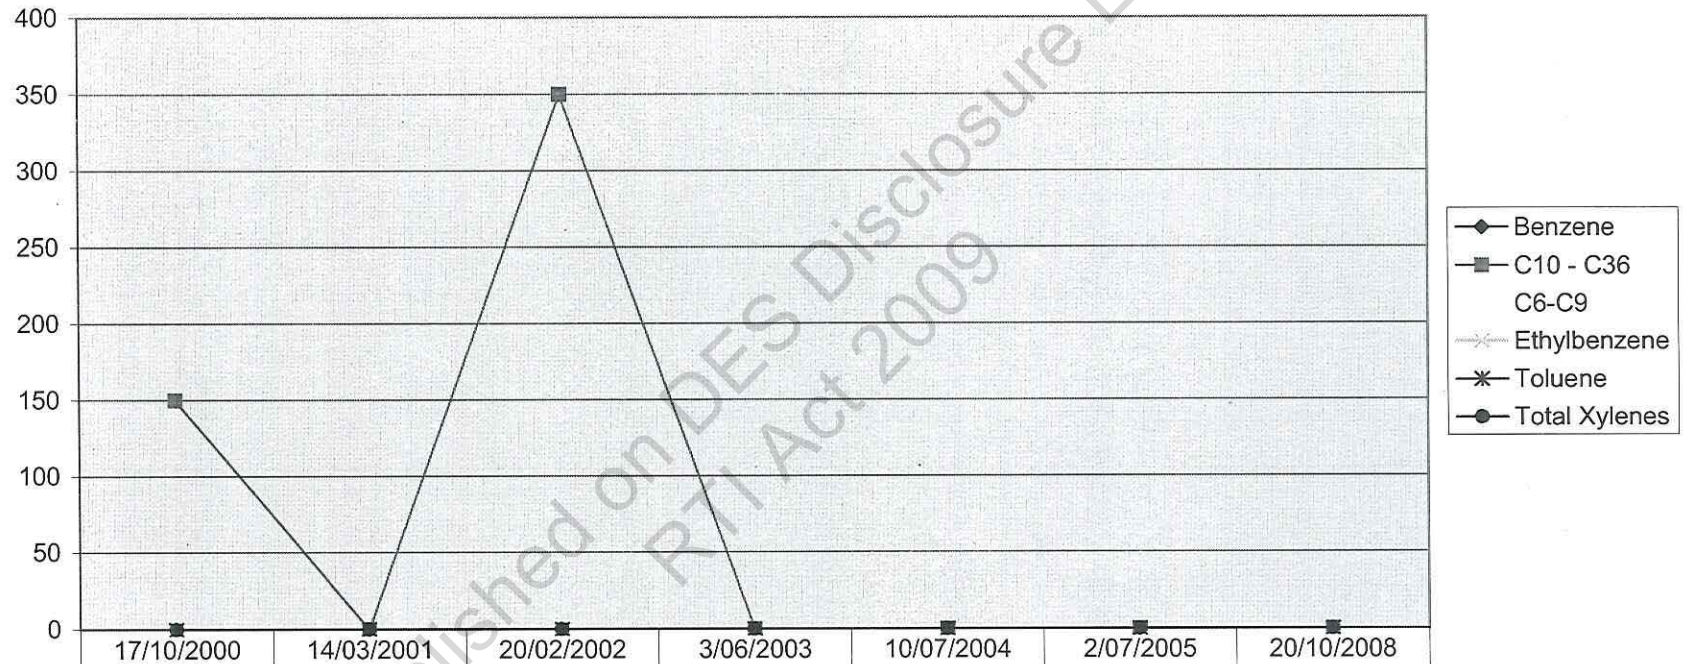
**Infrastructure Removal Characterisation and Environmental Site Assessment
Former Quilpie Depot CCM104Q
Graphical Trend Analysis - MW16**

◆ Benzene	0	0	0	0	0	0	0
■ C10 - C36	150	0	350	0	0	0	0
● C6-C9	0	0	0	0	0	0	0
✱ Ethylbenzene	0	0	0	0	0	0	0
✱ Toluene	0	0	0	0	0	0	0
● Total Xylenes	0	0	0	0	0	0	0

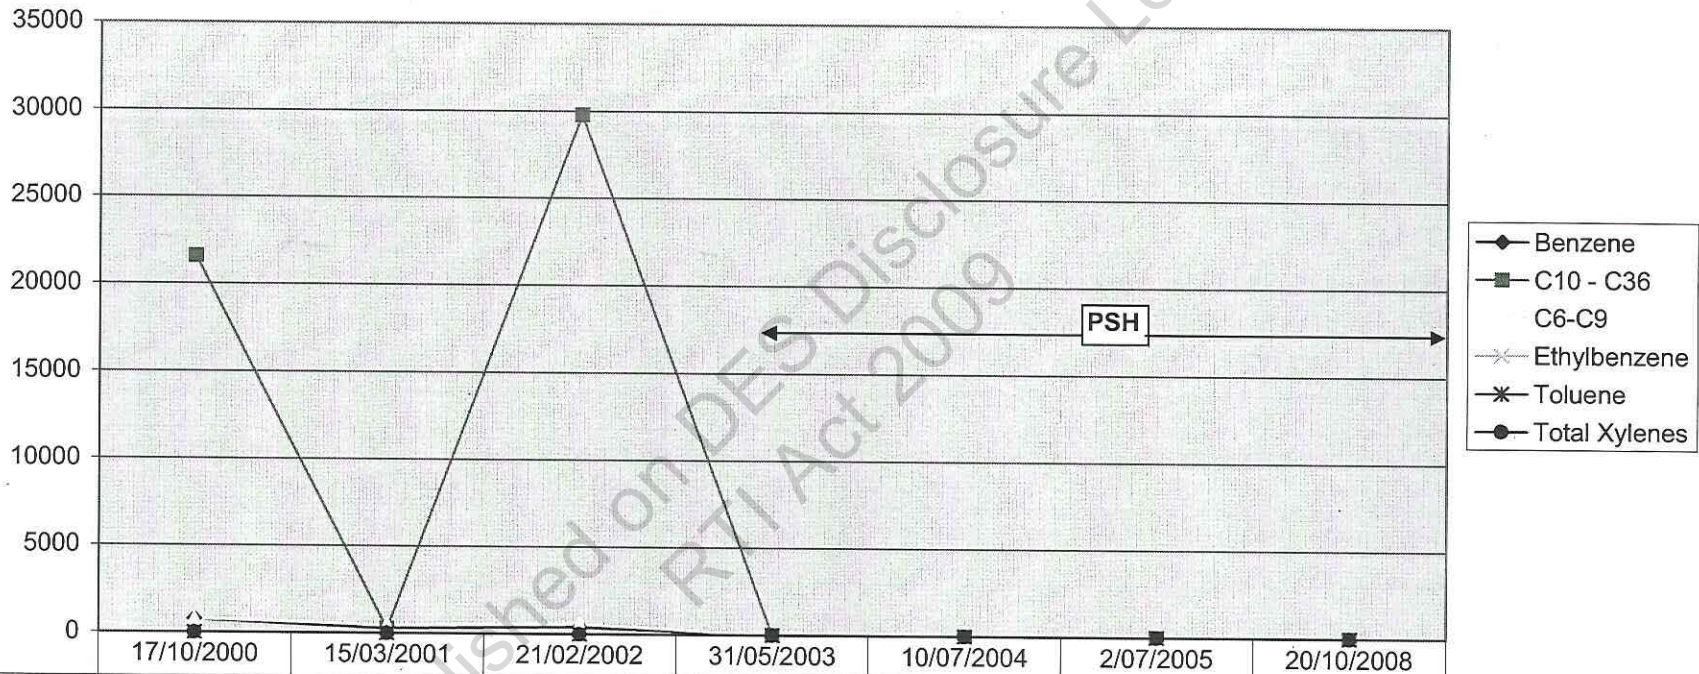
**Infrastructure Removal Characterisation and Environmental Site Assessment
Former Quilpie Depot CCM104Q
Graphical Trend Analysis - MW17**

17/10/2000	15/03/2001	21/02/2002	31/05/2003	10/07/2004	2/07/2005	20/10/2008
◆ Benzene	780	290	400	0	0	0	0
■ C10 - C36	21580	260	29800	0	0	0	0
□ C6-C9	780	470	600	0	0	0	0
✧ Ethylbenzene	0	0	2	0	0	0	0
✱ Toluene	0	1	2	0	0	0	0
● Total Xylenes	0	2	2	0	0	0	0

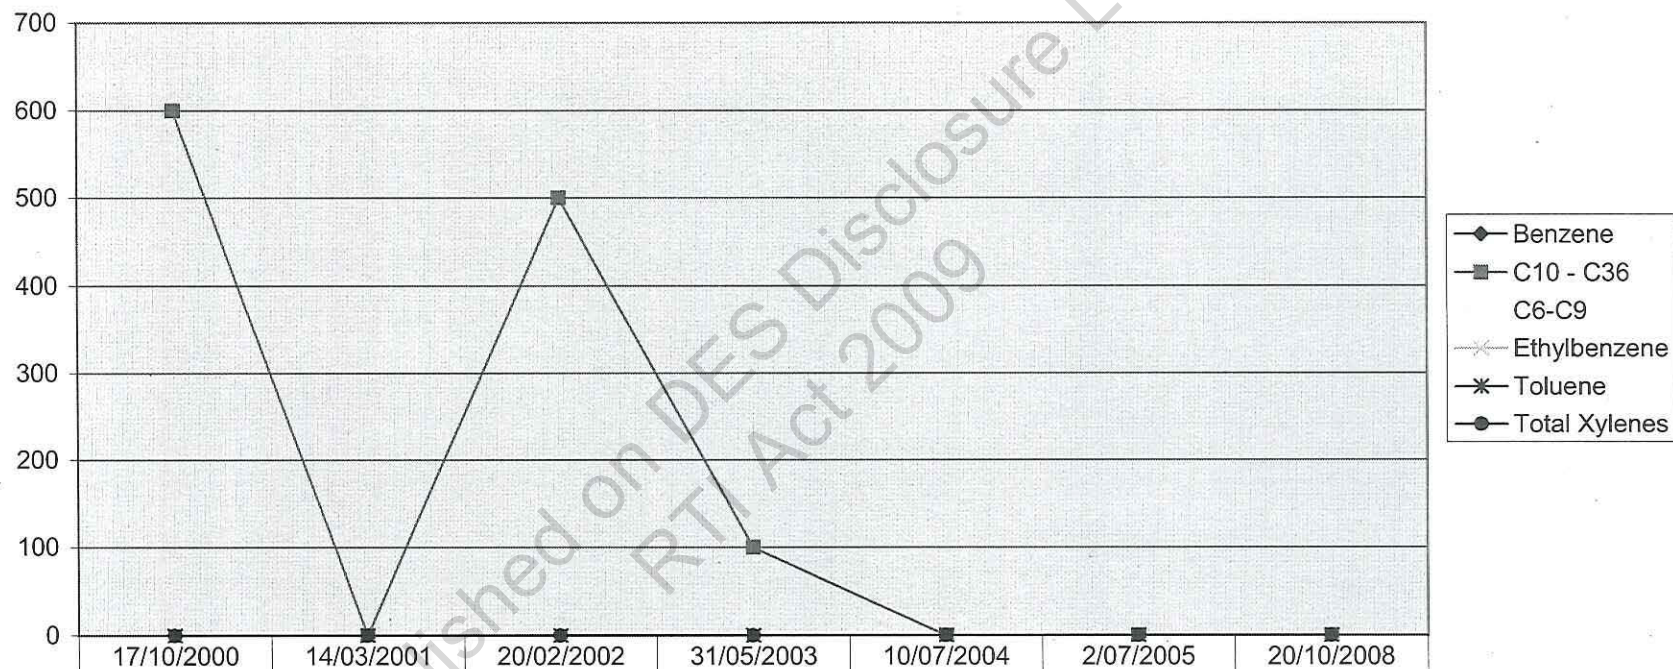
**Infrastructure Removal Characterisation and Environmental Site Assessment
Former Quilpie Depot CCM104Q
Graphical Trend Analysis - MW18**

17/10/2000	14/03/2001	20/02/2002	31/05/2003	10/07/2004	2/07/2005	20/10/2008
◆ Benzene	0	0	0	0	0	0	0
■ C10 - C36	600	0	500	100	0	0	0
● C6-C9	0	0	0	0	0	0	0
* Ethylbenzene	0	0	0	0	0	0	0
✱ Toluene	0	0	0	0	0	0	0
● Total Xylenes	0	0	0	0	0	0	0

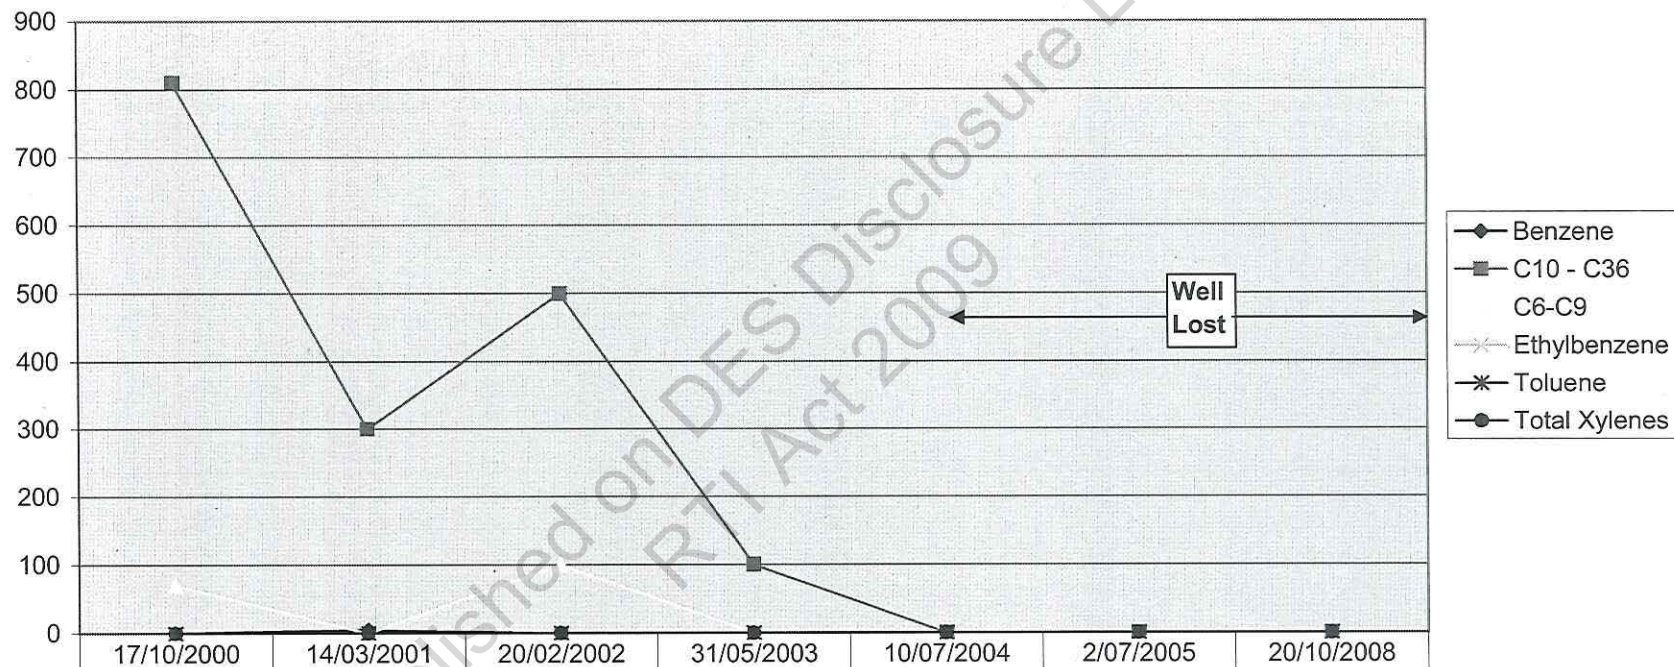
**Infrastructure Removal Characterisation and Environmental Site Assessment
Former Quilpie Depot CCM104Q
Graphical Trend Analysis - MW20**

17/10/2000	14/03/2001	20/02/2002	31/05/2003	10/07/2004	2/07/2005	20/10/2008
◆ Benzene	0	5	0	0	0	0	0
■ C10 - C36	810	300	500	100	0	0	0
□ C6-C9	70	0	100	0	0	0	0
✦ Ethylbenzene	0	0	0	0	0	0	0
✱ Toluene	0	0	0	0	0	0	0
● Total Xylenes	0	0	0	0	0	0	0

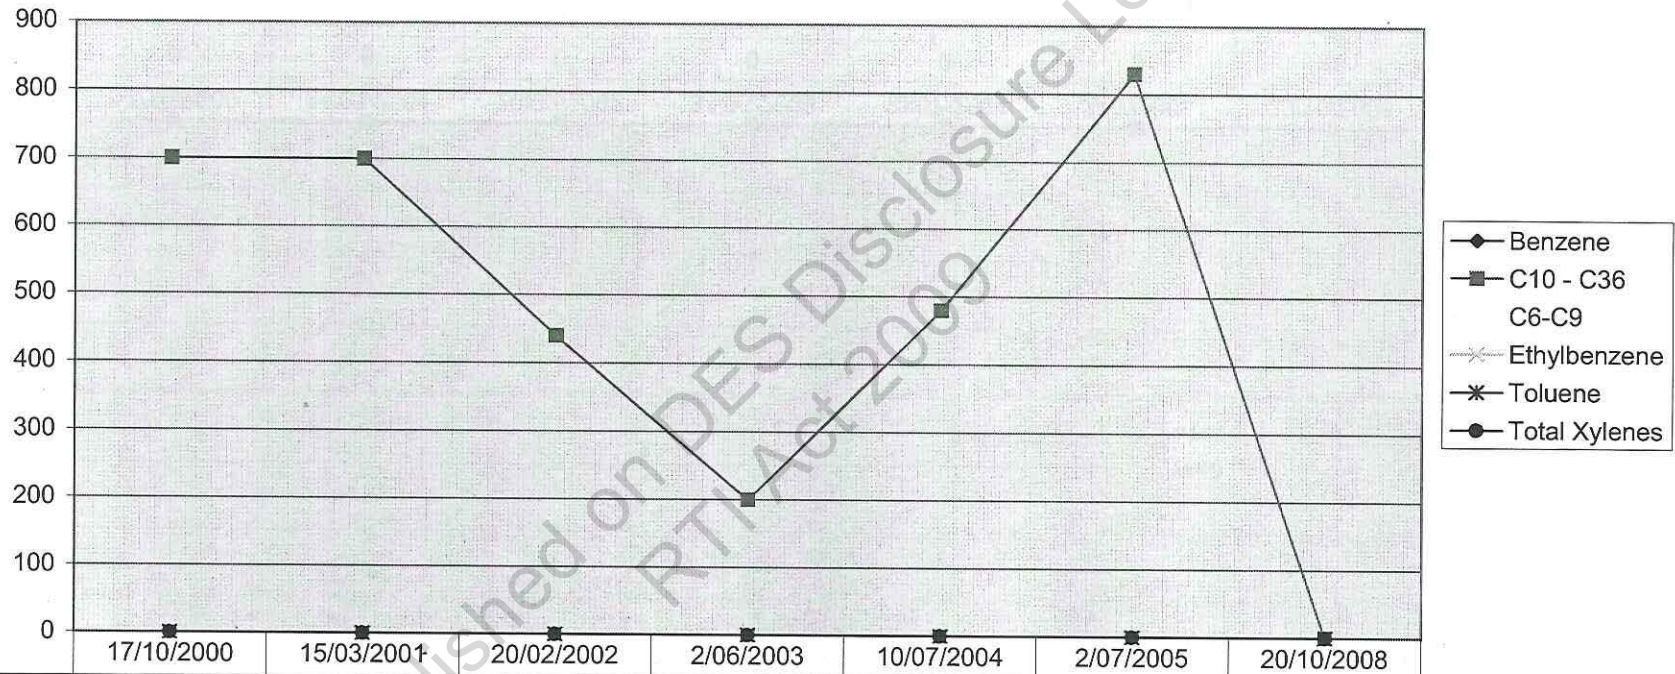
**Infrastructure Removal Characterisation and Environmental Site Assessment
Former Quilpie Depot CCM104Q
Graphical Trend Analysis - MW21**

◆ Benzene	0	0	0	0	0	0	0
■ C10 - C36	700	700	440	200	480	830	0
□ C6-C9	0	0	0	0	0	0	0
✕ Ethylbenzene	0	0	0	0	0	0	0
* Toluene	0	0	0	0	0	0	0
● Total Xylenes	0	0	0	0	0	0	0

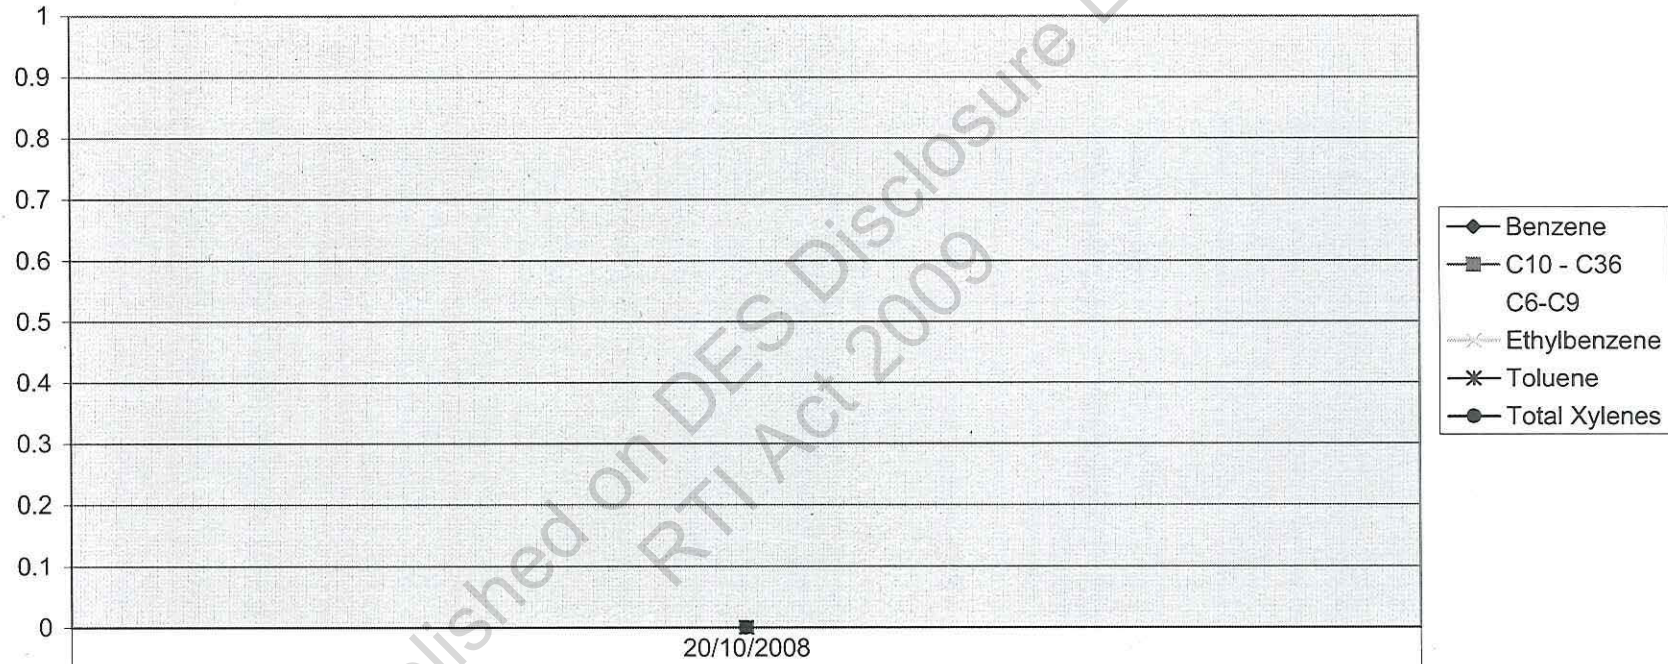
**Infrastructure Removal Characterisation and Environmental Site Assessment
Former Quilpie Depot CCM104Q
Graphical Trend Analysis - MW22**

◆ Benzene	0
■ C10 - C36	0
■ C6-C9	0
⊠ Ethylbenzene	0
* Toluene	0
● Total Xylenes	0

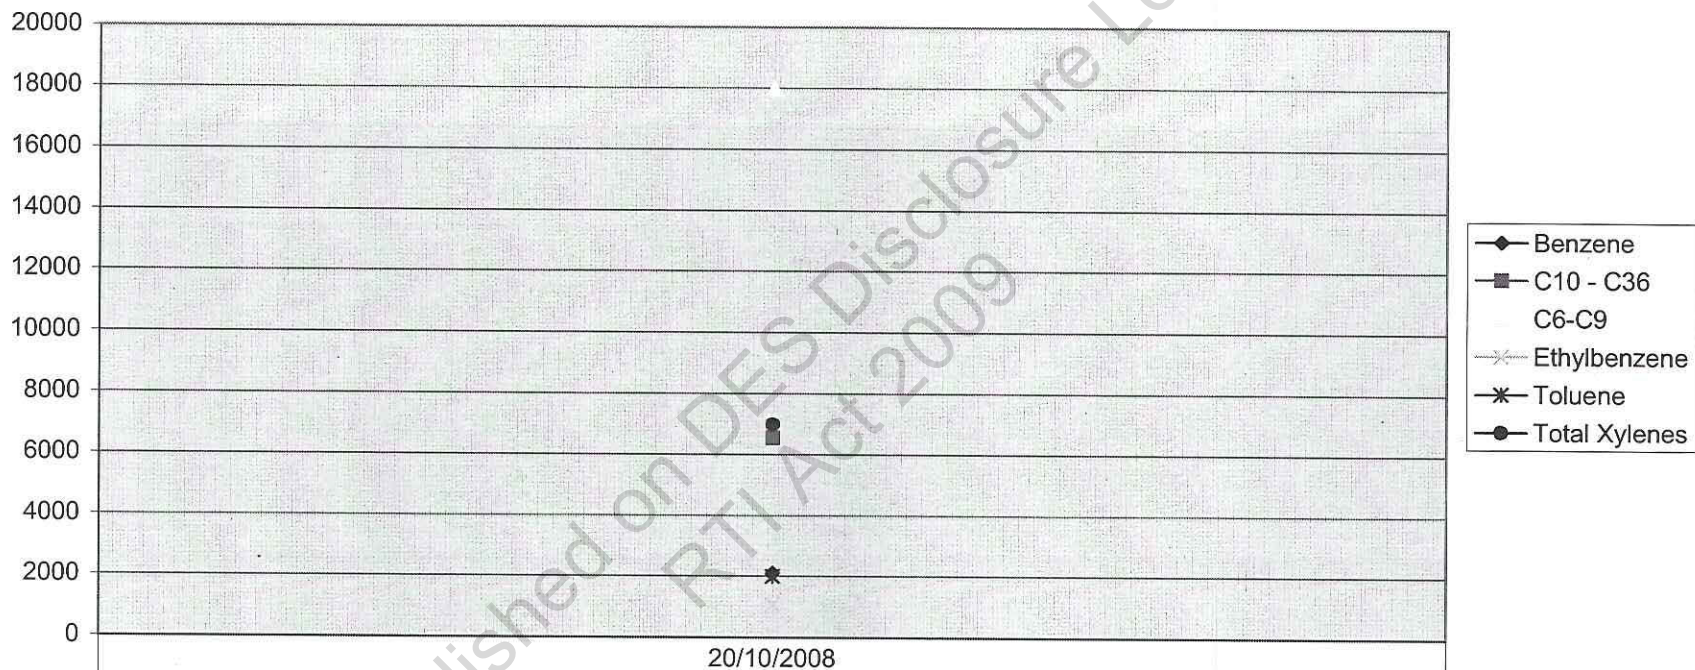
**Infrastructure Removal Characterisation and Environmental Site Assessment
Former Quilpie Depot CCM104Q
Graphical Trend Analysis - MW24**

20/10/2008
◆ Benzene	2100
■ C10 - C36	6550
□ C6-C9	18000
✱ Ethylbenzene	1100
* Toluene	2000
● Total Xylenes	7000

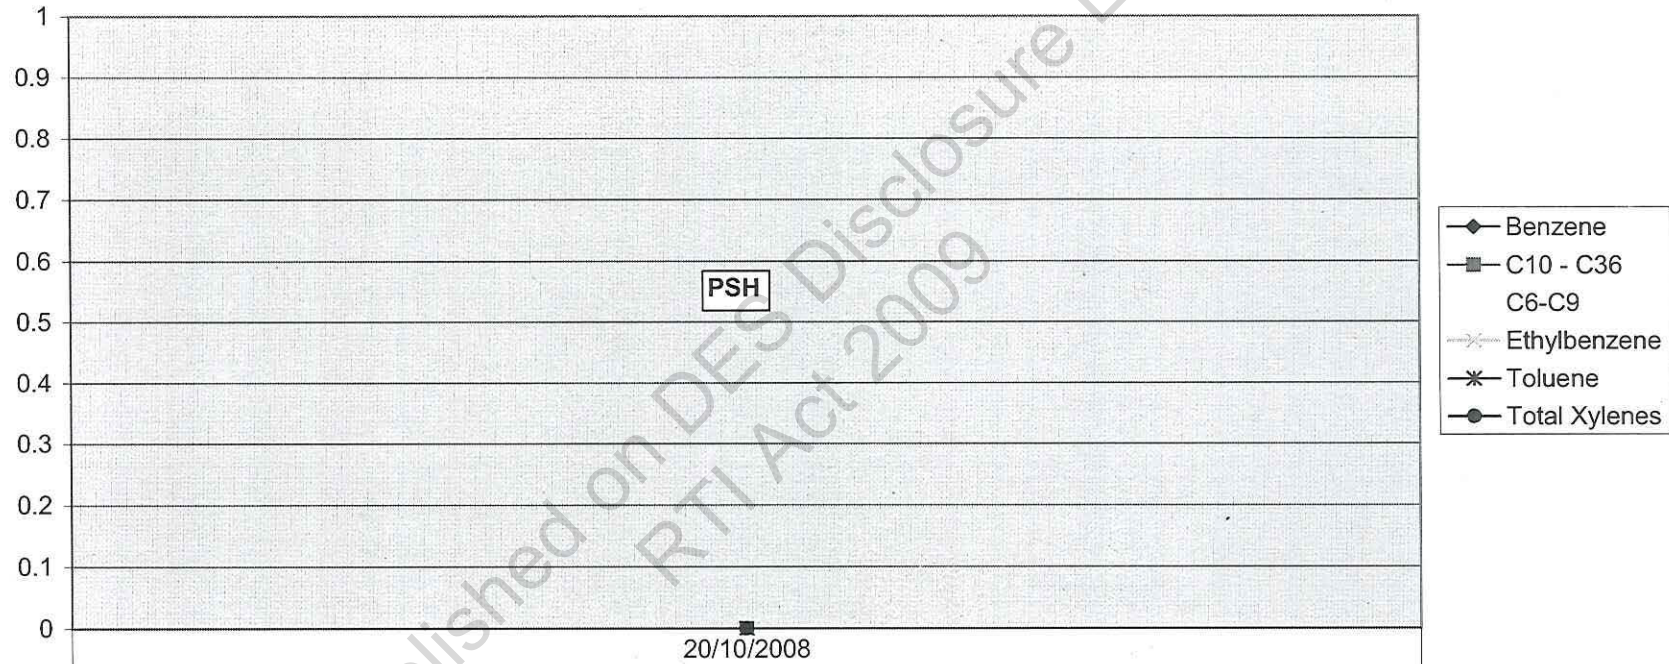
**Infrastructure Removal Characterisation and Environmental Site Assessment
Former Quilpie Depot CCM104Q
Graphical Trend Analysis - MW25**

◆ Benzene	0
■ C10 - C36	0
■ C6-C9	0
✦ Ethylbenzene	0
* Toluene	0
● Total Xylenes	0

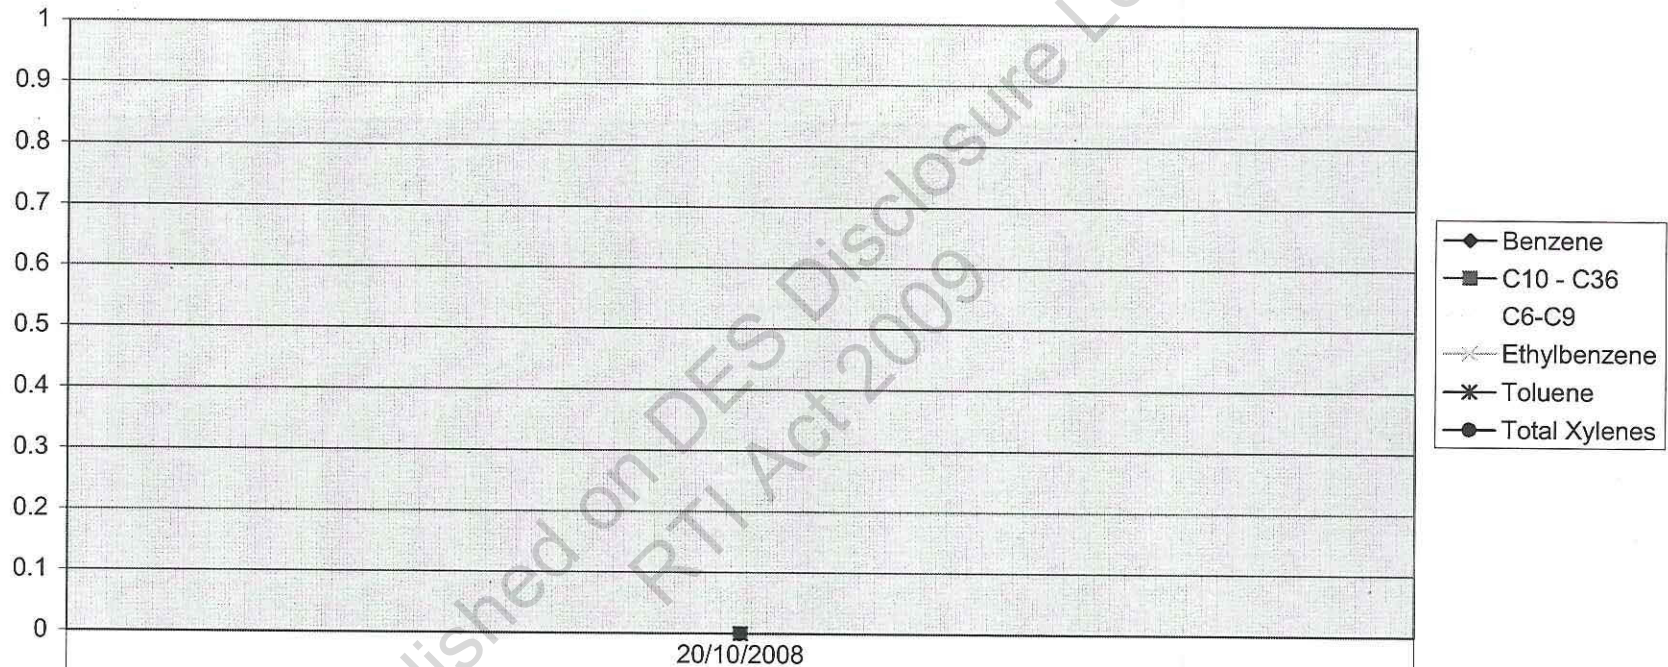
**Infrastructure Removal Characterisation and Environmental Site Assessment
Former Quilpie Depot CCM104Q
Graphical Trend Analysis - MW26**

◆ Benzene	0
■ C10 - C36	0
● C6-C9	0
⊗ Ethylbenzene	0
* Toluene	0
● Total Xylenes	0
