**Infrastructure Removal Characterisation and Environmental Site Assessment
Former Quilpie Depot CCM104Q
Graphical Trend Analysis - MW7**

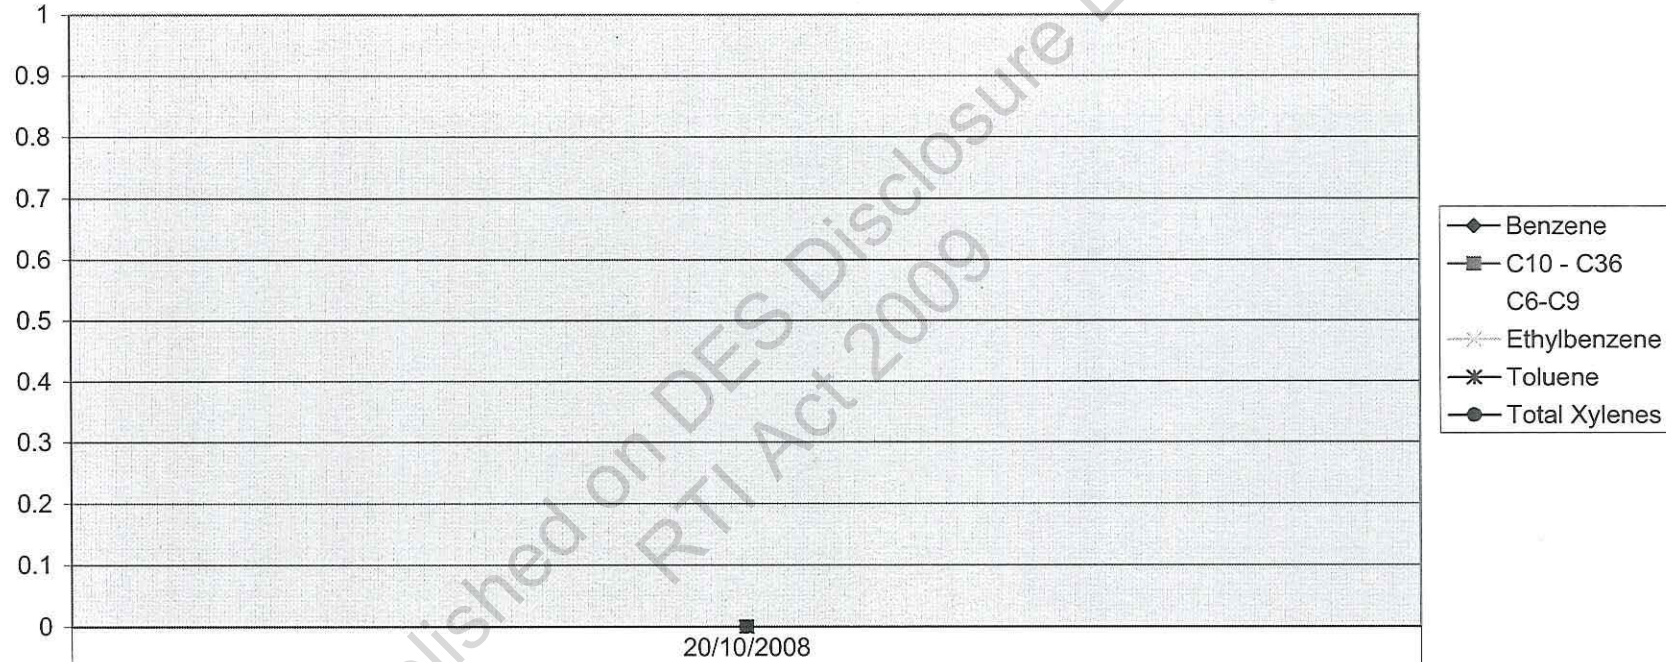
**Infrastructure Removal Characterisation and Environmental Site Assessment
Former Quilpie Depot CCM104Q
Graphical Trend Analysis - MW27**

◆ Benzene	0
■ C10 - C36	0
□ C6-C9	0
✱ Ethylbenzene	0
✱ Toluene	0
● Total Xylenes	0

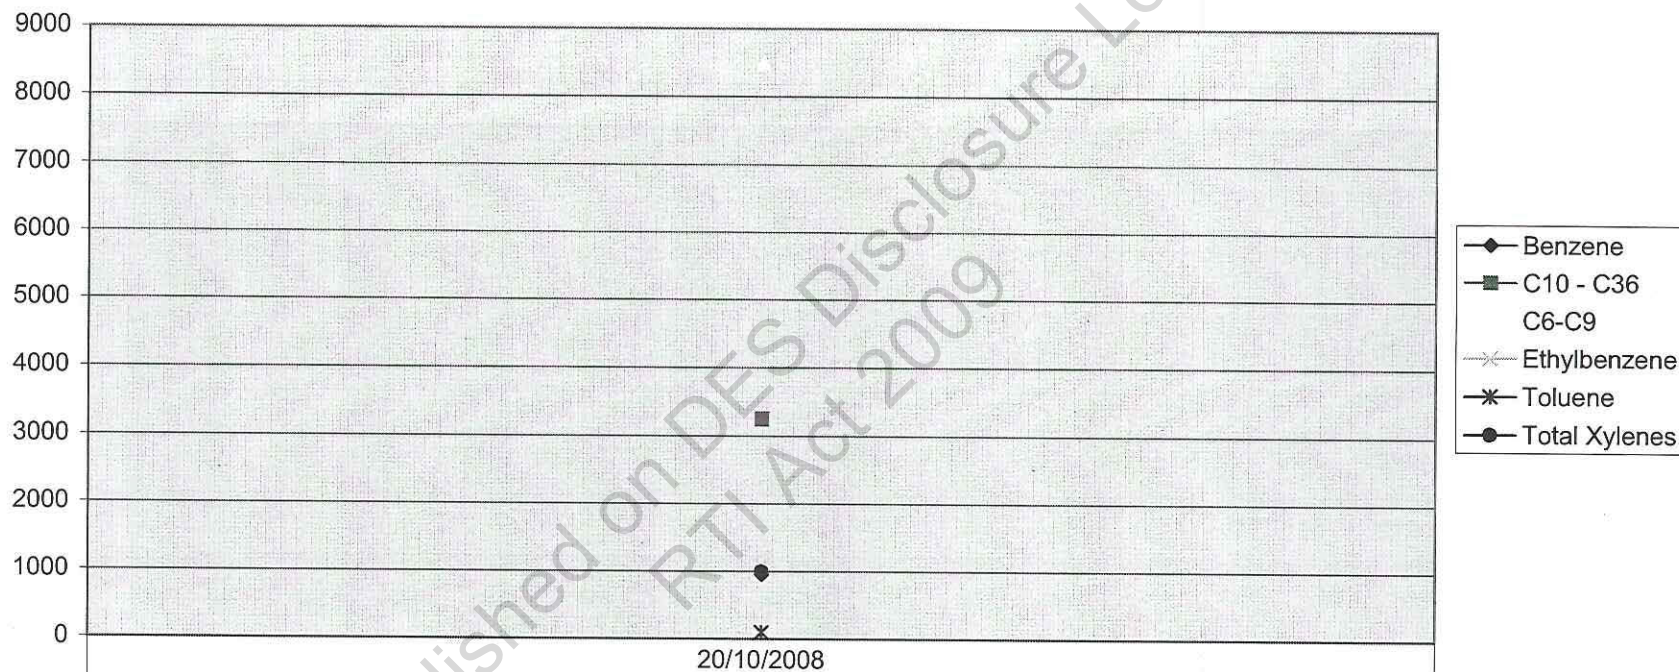
**Infrastructure Removal Characterisation and Environmental Site Assessment
Former Quilpie Depot CCM104Q
Graphical Trend Analysis - MW28**

◆ Benzene	960
■ C10 - C36	3250
□ C6-C9	8500
× Ethylbenzene	1100
* Toluene	100
● Total Xylenes	1000

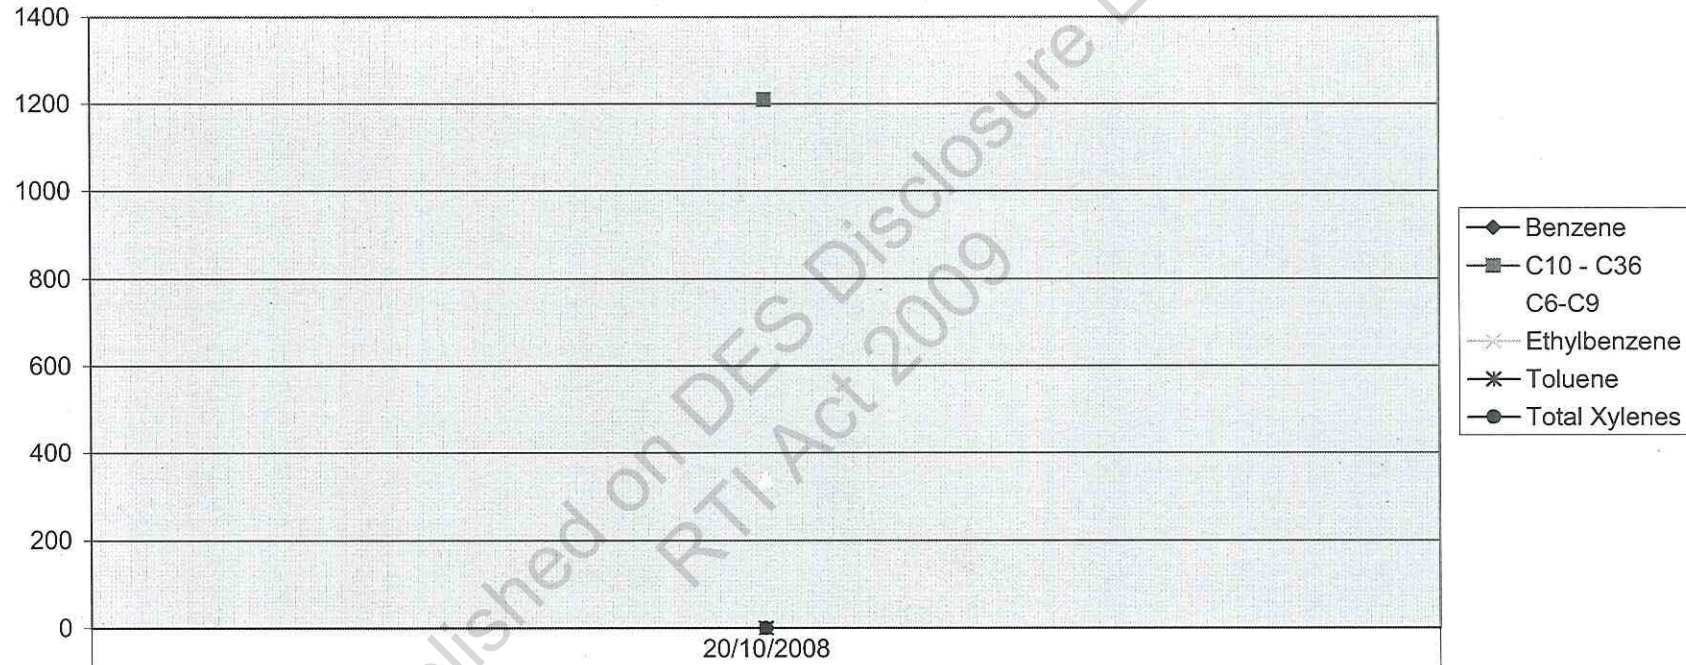
**Infrastructure Removal Characterisation and Environmental Site Assessment
Former Quilpie Depot CCM104Q
Graphical Trend Analysis - MW29**

20/10/2008
◆ Benzene	0
■ C10 - C36	1210
● C6-C9	340
* Ethylbenzene	0
✱ Toluene	0
● Total Xylenes	0

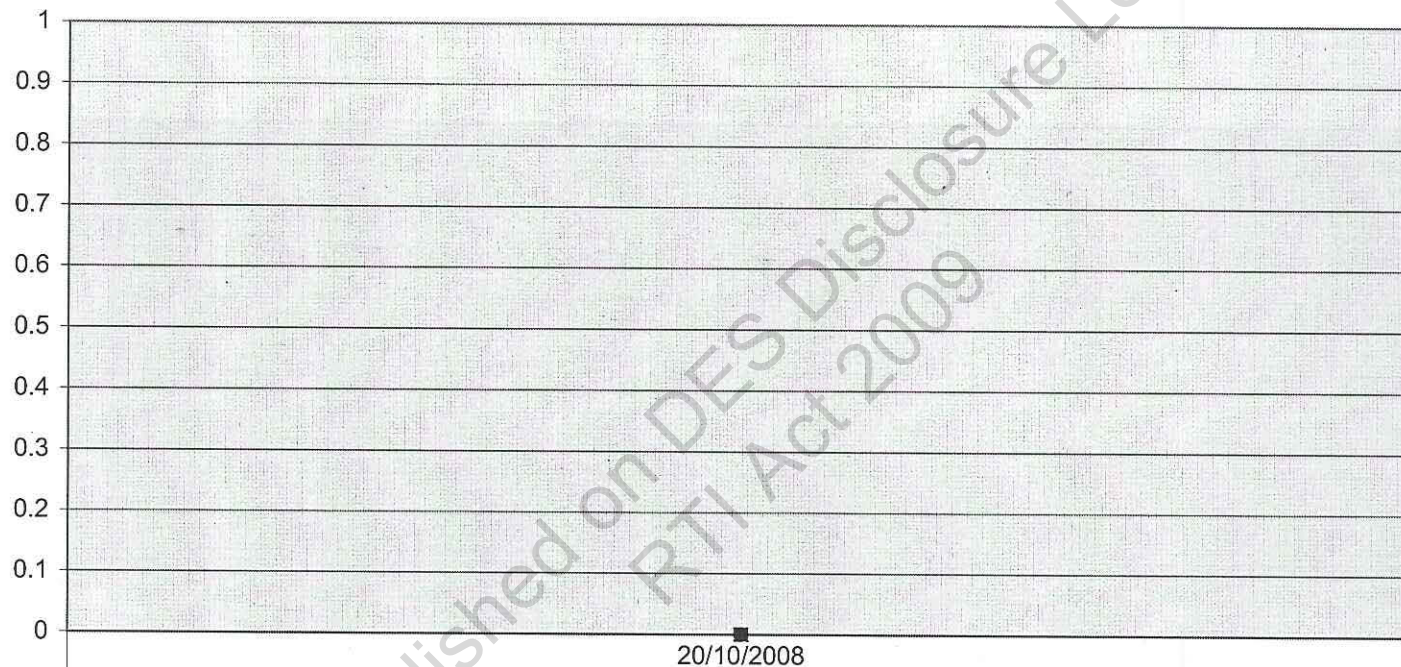
**Infrastructure Removal Characterisation and Environmental Site Assessment
Former Quilpie Depot CCM104Q
Graphical Trend Analysis - MW30**

◆	Benzene	0
■	C10 - C36	0
□	C6-C9	0
✱	Ethylbenzene	0
✱	Toluene	0
●	Total Xylenes	0
